#### IV. PLUMBING SYSTEMS

##### A. Plumbing Supply, Distribution Systems and Fixtures

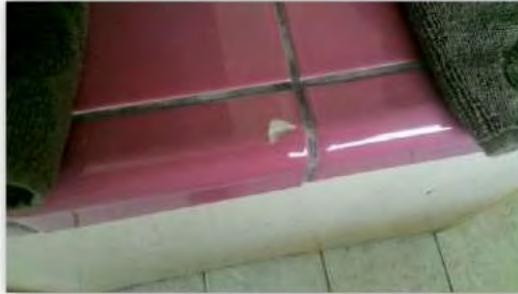
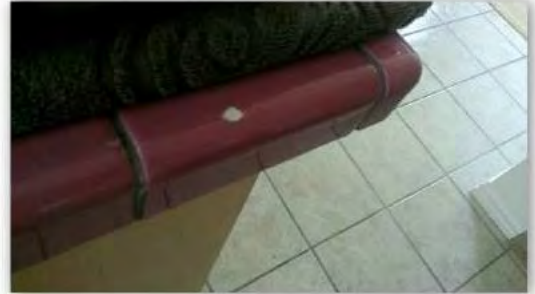
Loose, damaged or missing tile in plumbing enclosure at: Kitchen Island - "[§535.231 \(a\)\(2\)\(E\)\(viii\)](#)"

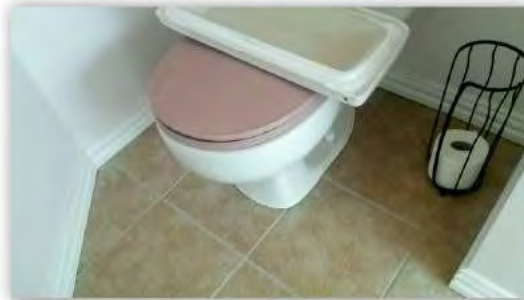
The commode is loose at the floor mounting at: Hall Bathroom (1st Floor) Commode - "[§535.231 \(a\)\(2\)\(E\)\(viii\)](#)"

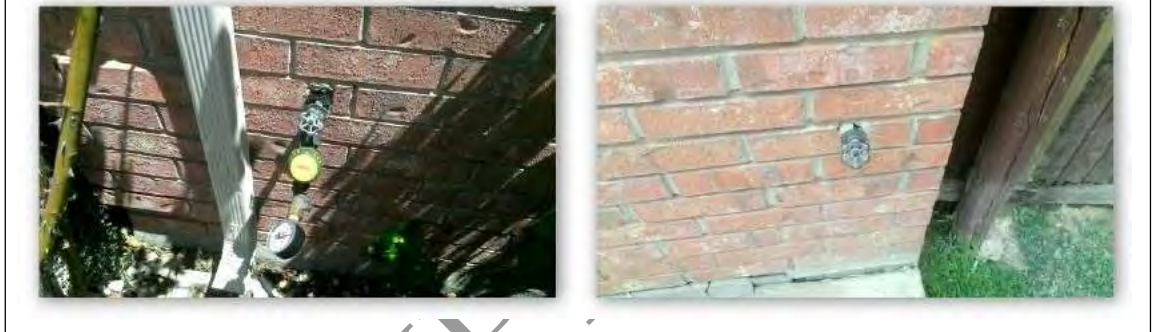
Fixture is loose at mounting at: Exterior Rear, Exterior Front - "[§535.231 \(a\)\(2\)\(E\)\(viii\)](#)"

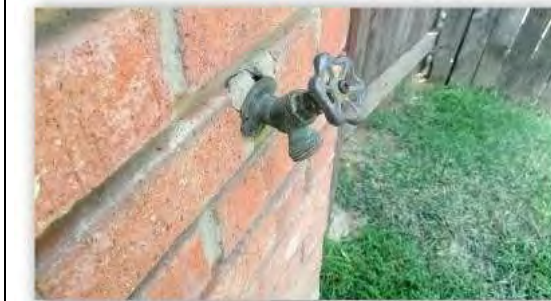
No anti-siphon device installed at: Exterior Front, Exterior Rear - "[§535.231 \(a\)\(2\)\(D\)\(iii\)](#)"

Anti-siphon devices prevent contaminated water from being drawn into the plumbing supply system.

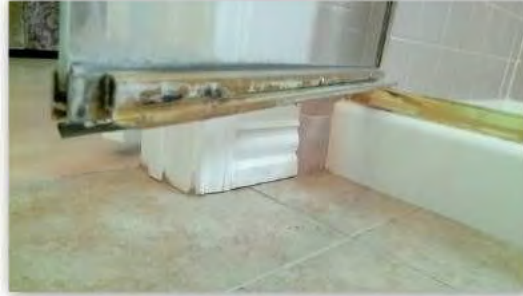
The enclosure door is missing a weather strip at the bottom connection: Master Bathroom Shower. - A weather strip will prevent water splash from landing outside of the enclosure.  
"[§535.231 \(a\)\(2\)\(E\)\(viii\)](#)"

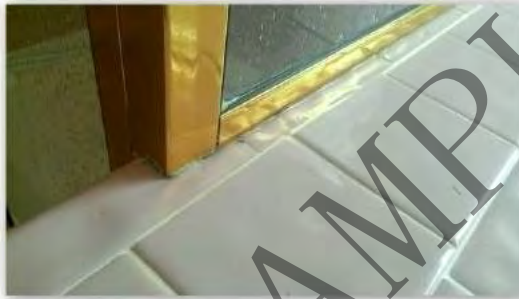
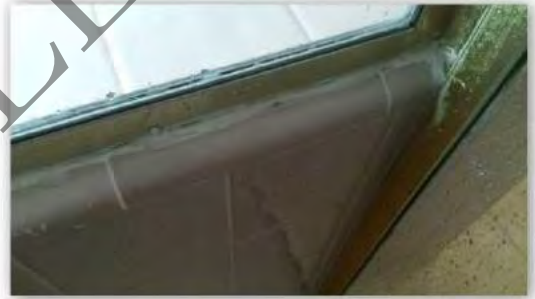
Shower enclosure is leaking at: Master Bathroom Shower. Recommend repair to the caulking on the inside of the enclosure. - "[§535.231 \(a\)\(2\)\(E\)\(viii\)](#)"

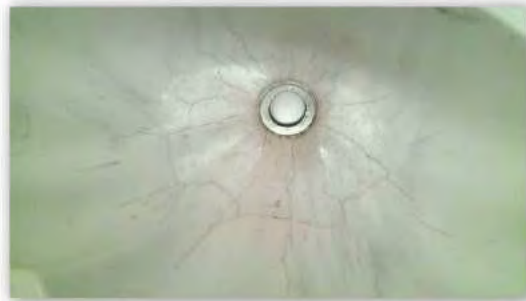
Damage to finish at: Hall Bathroom (1st Floor) Sink - "[§535.231 \(a\)\(2\)\(E\)\(viii\)](#)"

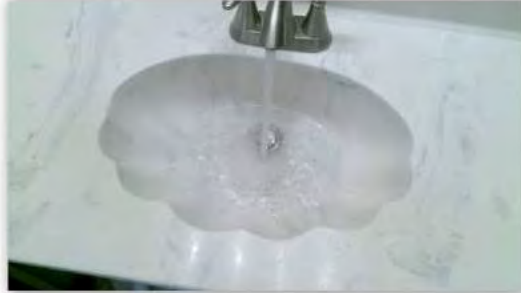
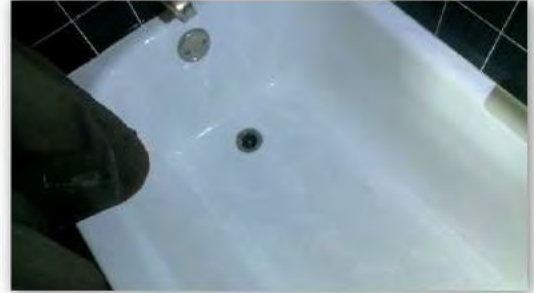
Drain stop missing/needs adjustment at: Hall Bathroom (1st Floor) Sink, Hall Bathroom (1st Floor) Tub - "[§535.231 \(a\)\(2\)\(E\)\(v\)](#)"

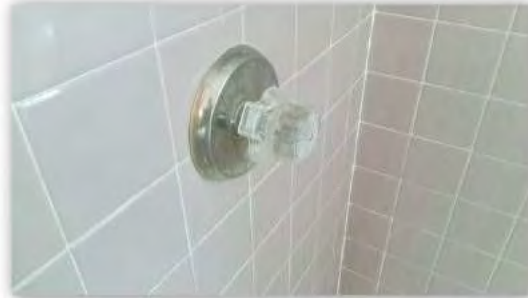
The master shower temperature setting knob is difficult to adjust. - "[§535.231 \(a\)\(2\)\(E\)](#)"

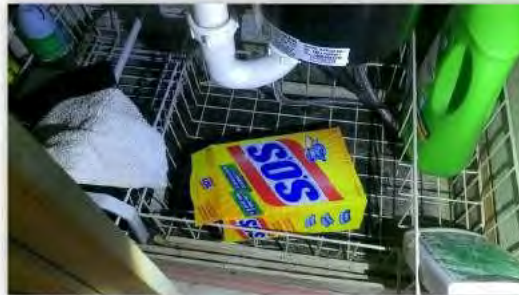
The kitchen sink cabinet does not have a bottom. - "[§535.231 \(a\)\(2\)\(E\)](#)"

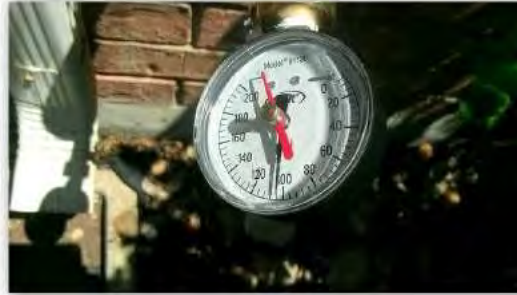
PSI(water pressure) measurement:- "[§535.231 \(a\)\(2\)\(E\)](#)"
