Anchor Inspection Group
972-655-9601
heath@anchorinspectiongroup.com

Summary

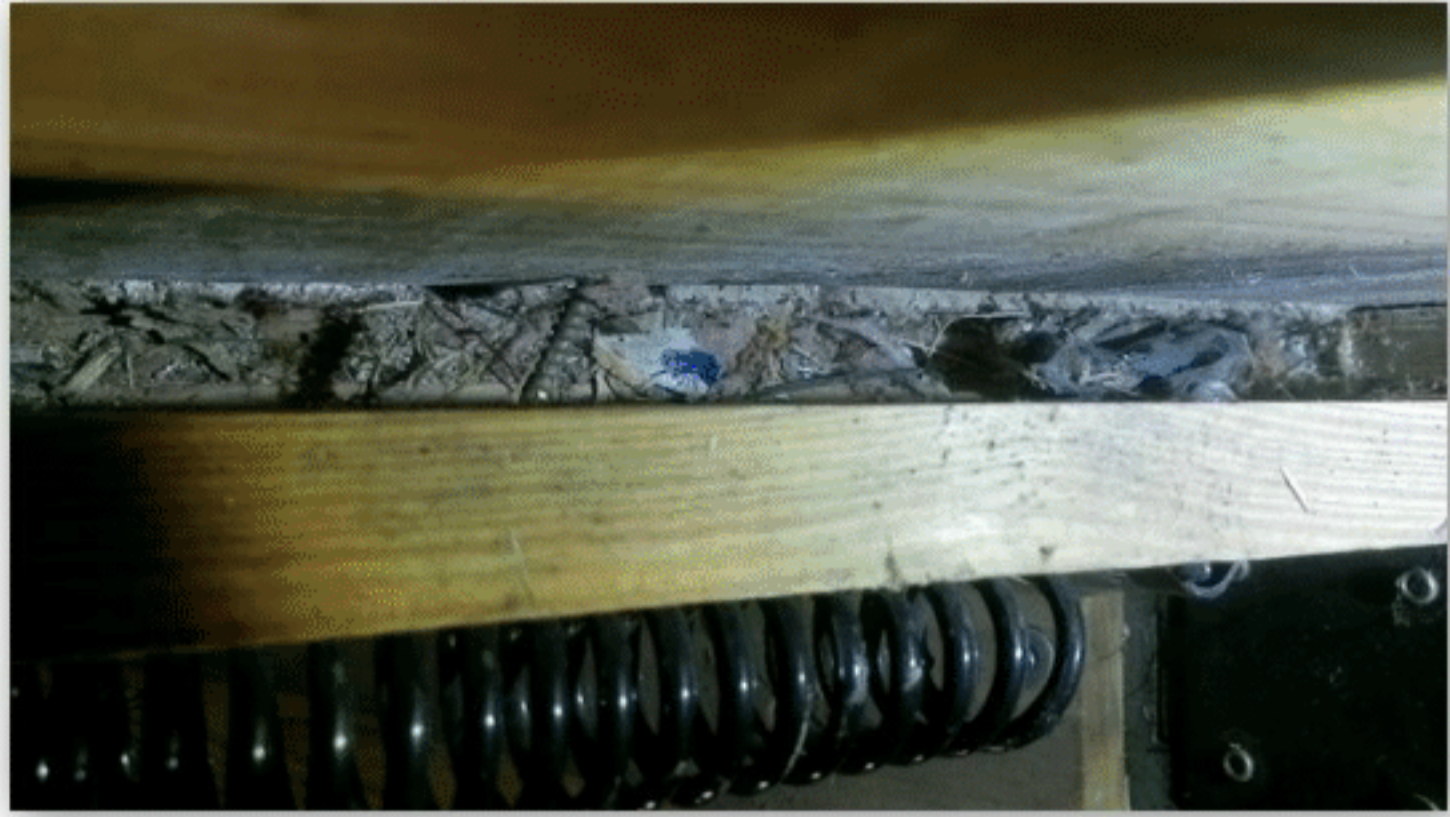
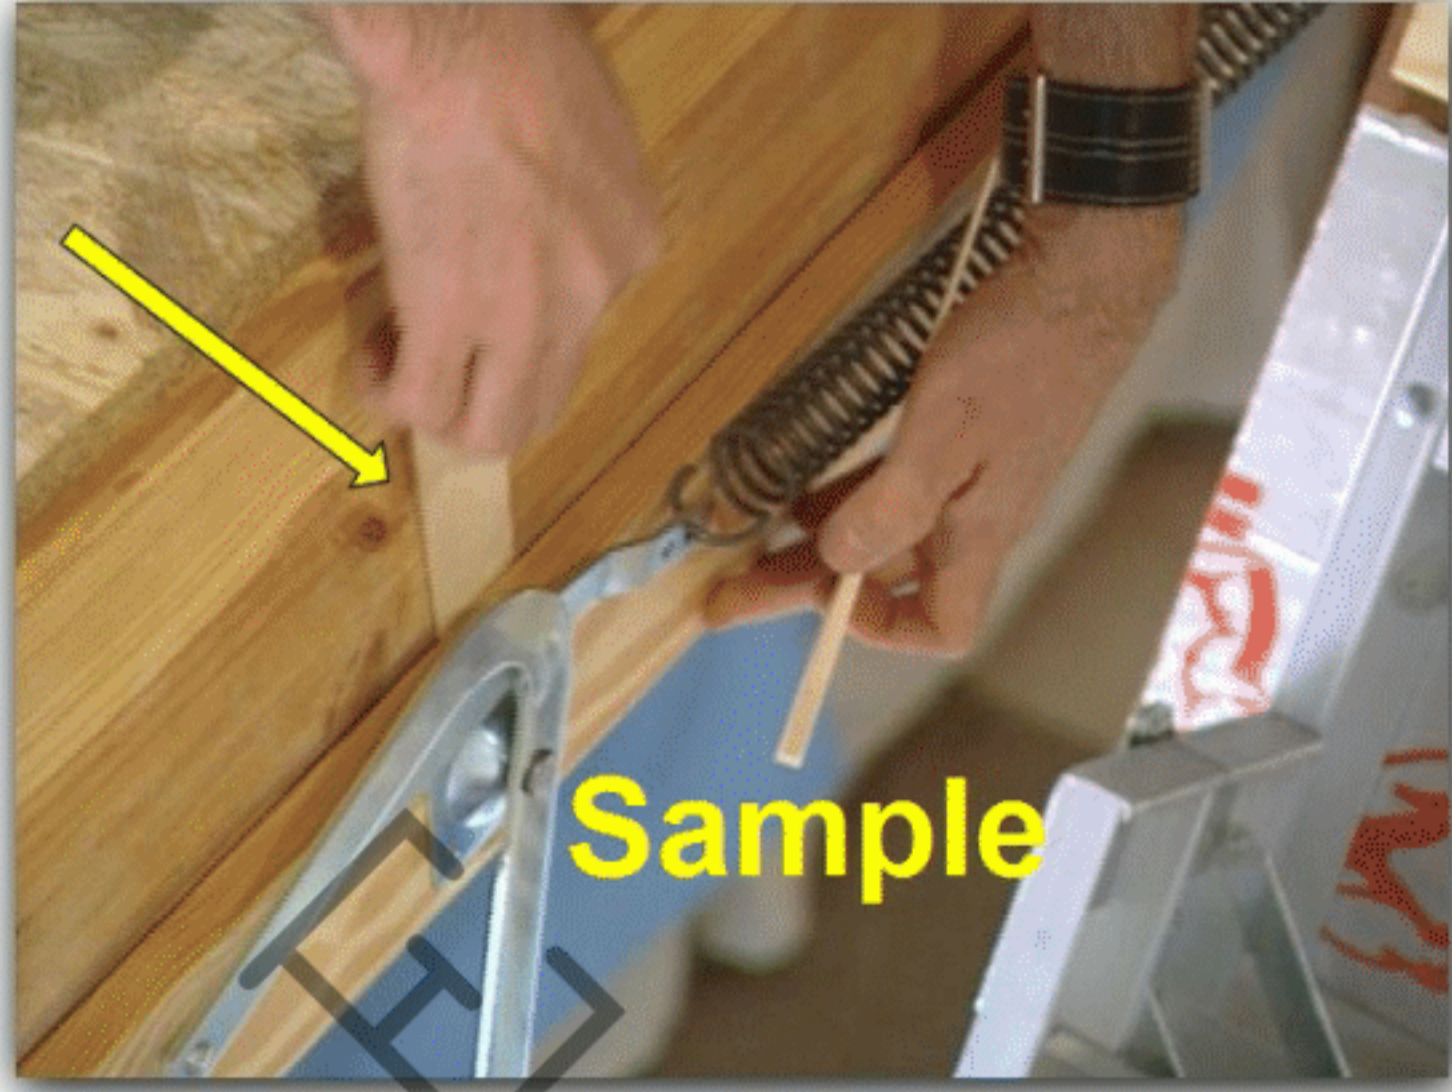
<p>The recommended spacers/shims are missing from the attic hatch installation. - "§535.228 (d)(2)(A)"</p>	<p>Shims serve as a spacer in the hatch installation. The manufacturer usually includes shims with the installation materials. In some cases, additional shims may be needed.</p>

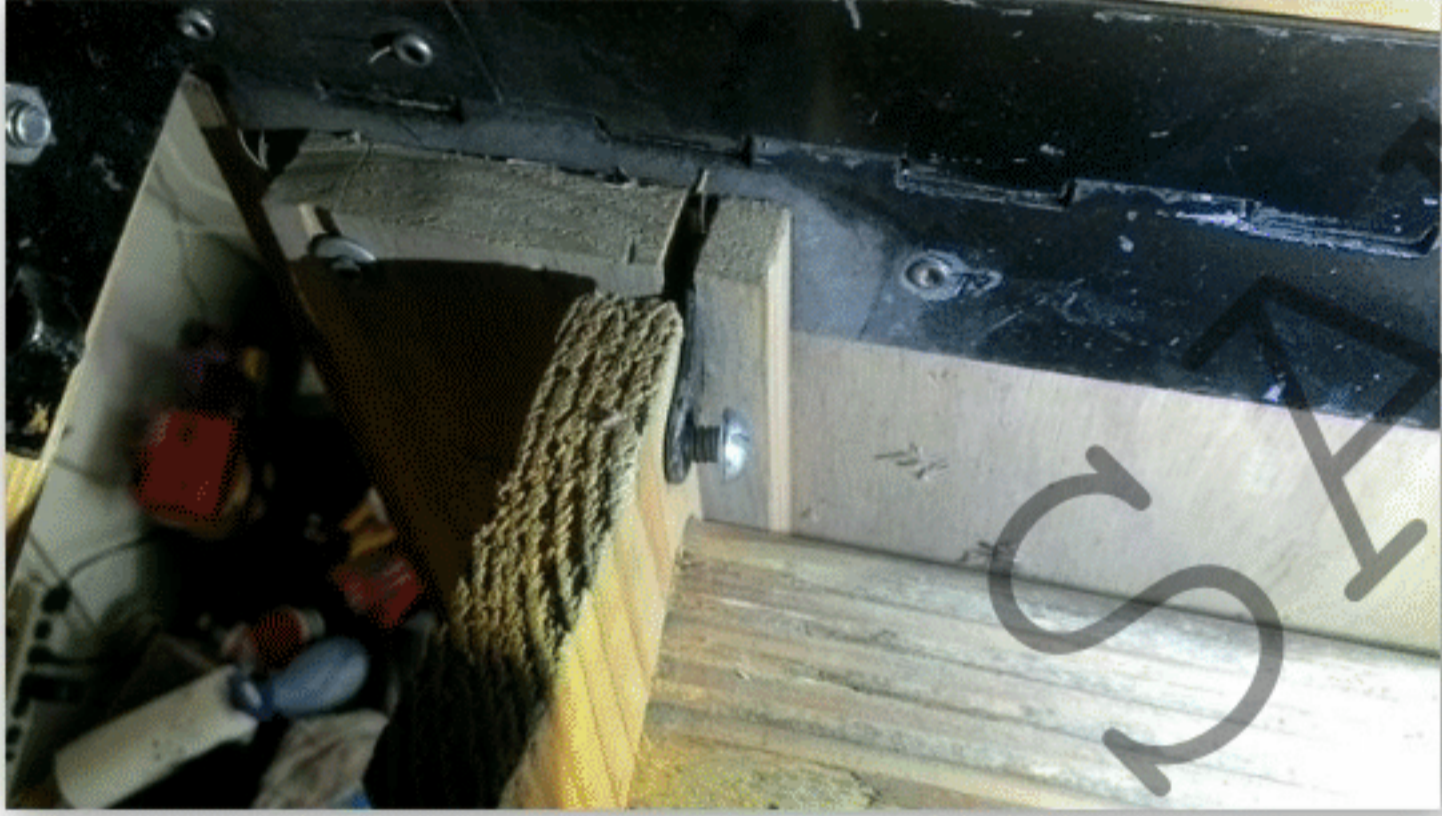
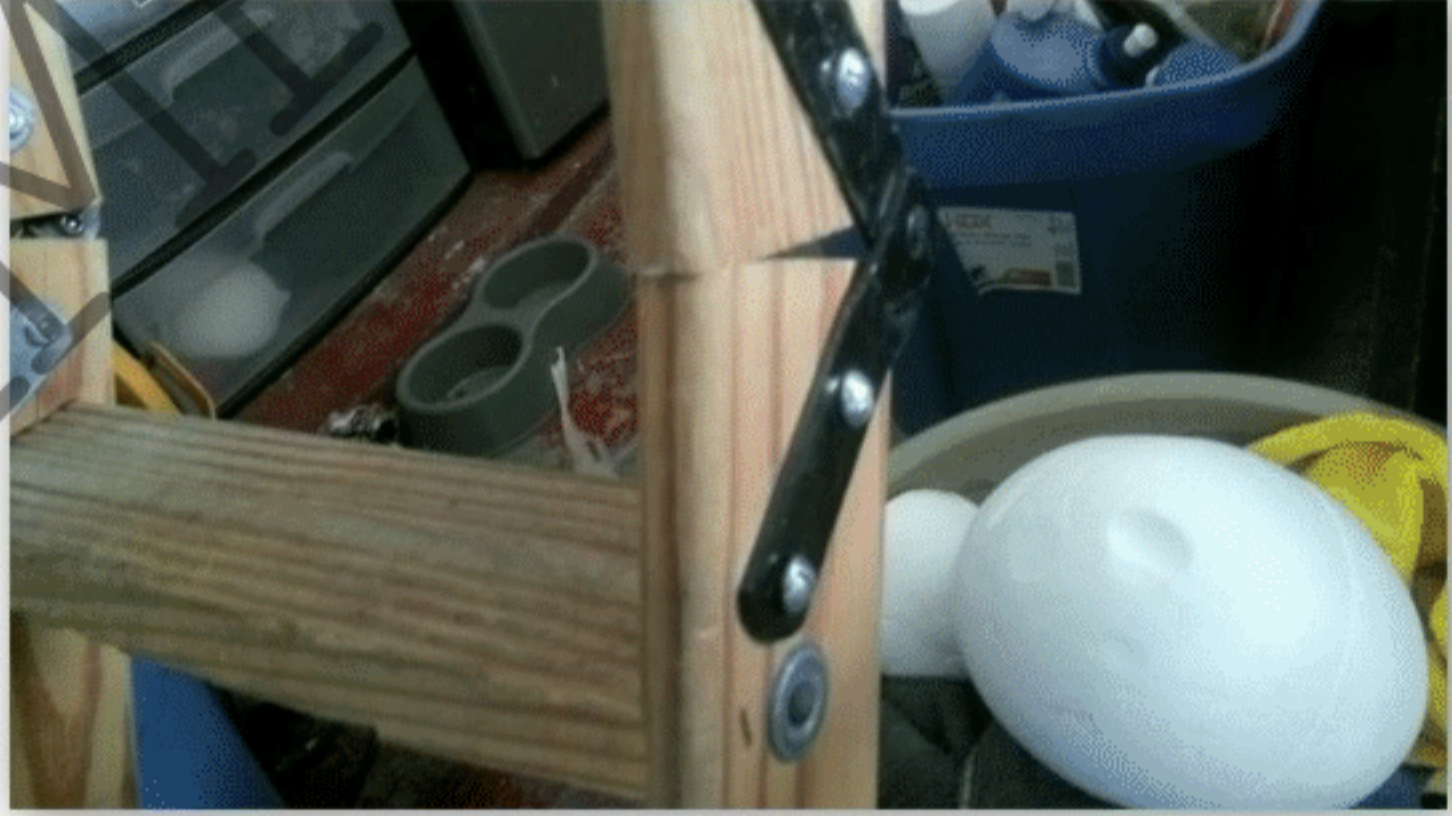
<p>The attic access ladder/hatch is in need of adjustment/repair. - "§535.228 (d)(2)(D)(ii)"</p>

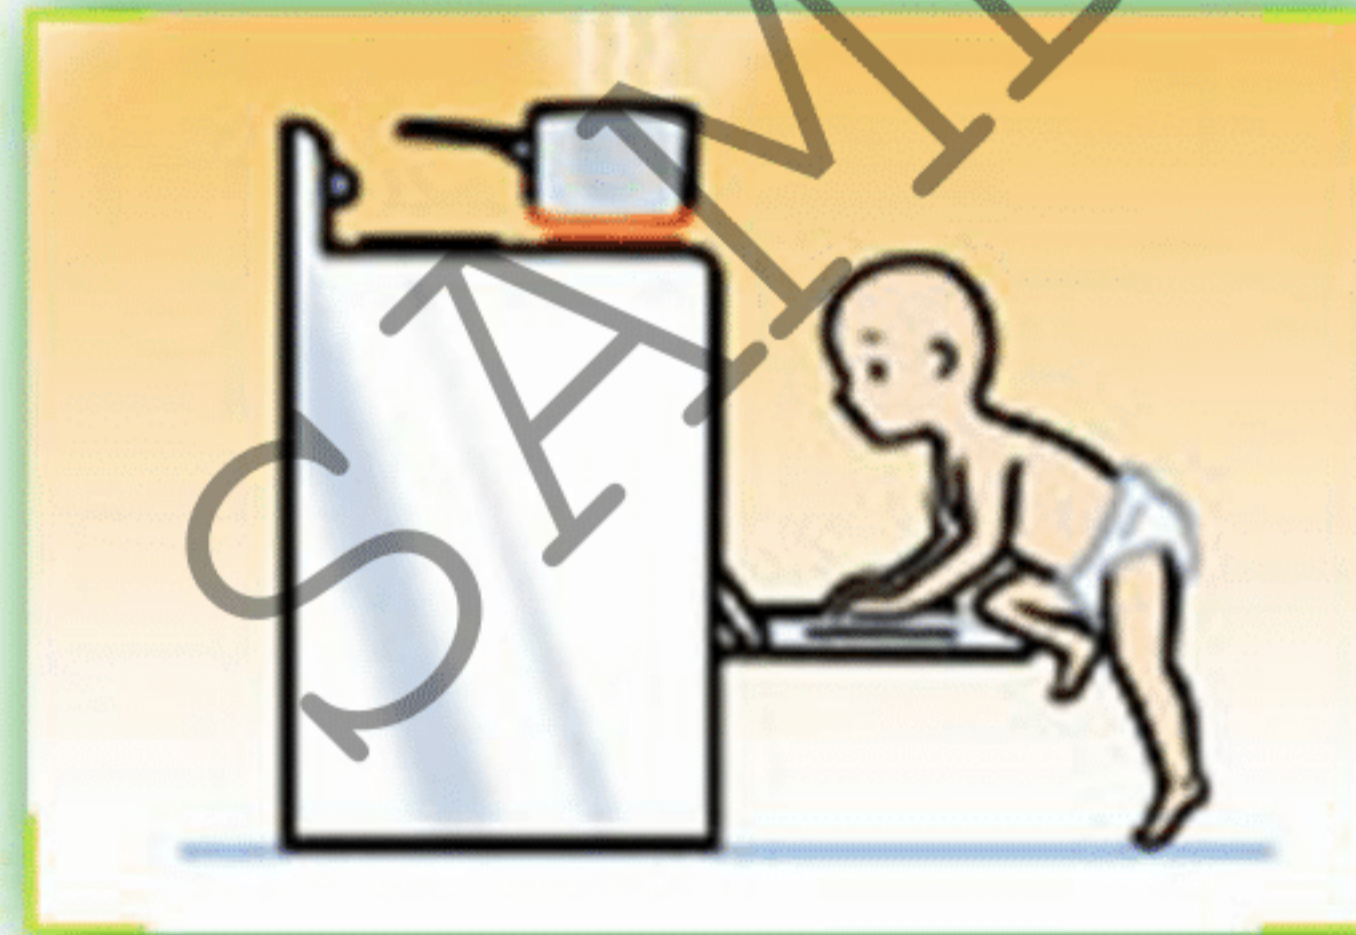
There is no anti-tip device installed on the free-standing oven. - "[§535.232 \(d\)\(4\)](#)"

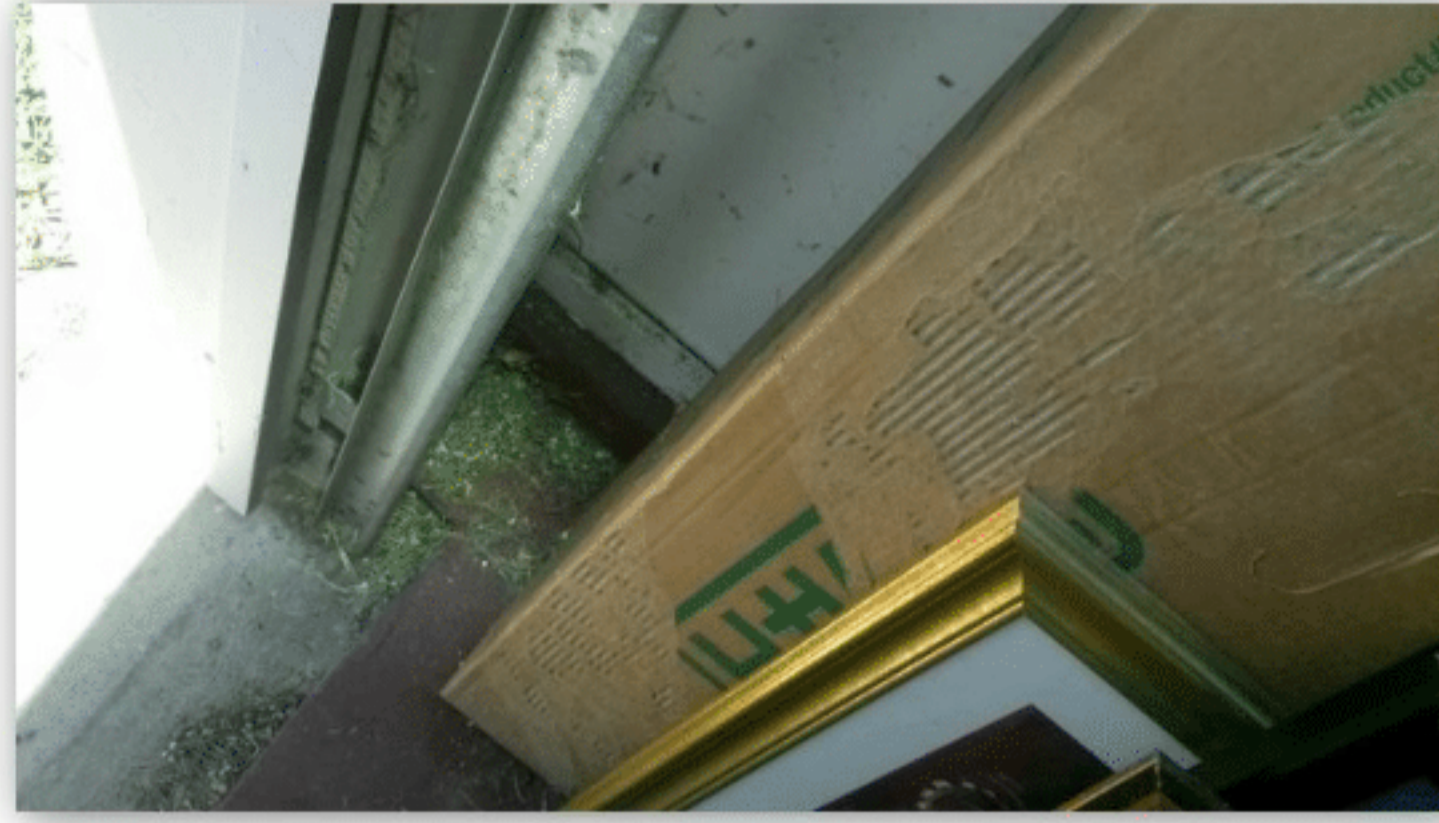
The auto-reverse feature is not installed. - "[§535.232 \(g\)](#)"

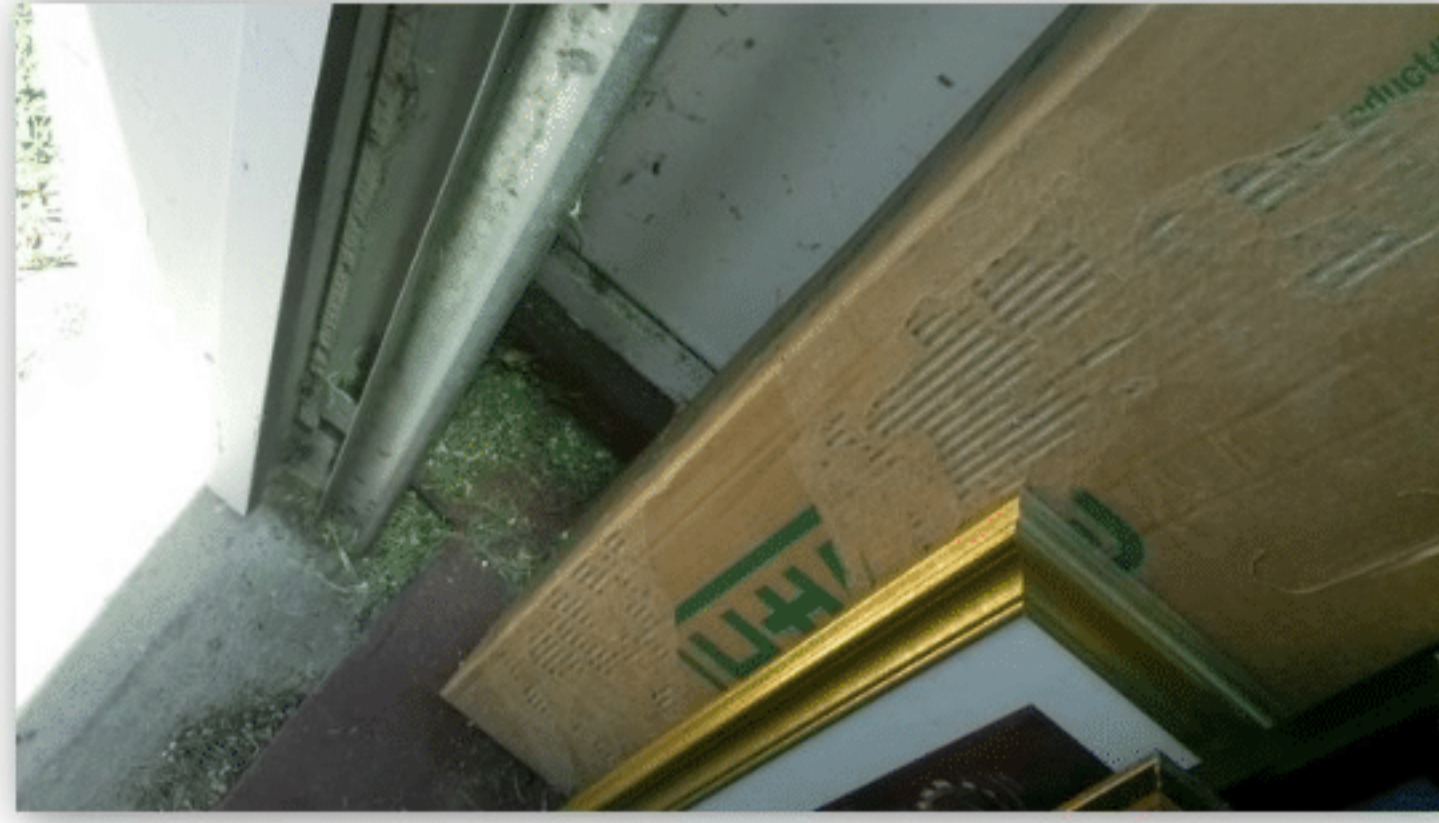
The auto-reverse feature is not installed. - "[§535.232 \(g\)](#)"

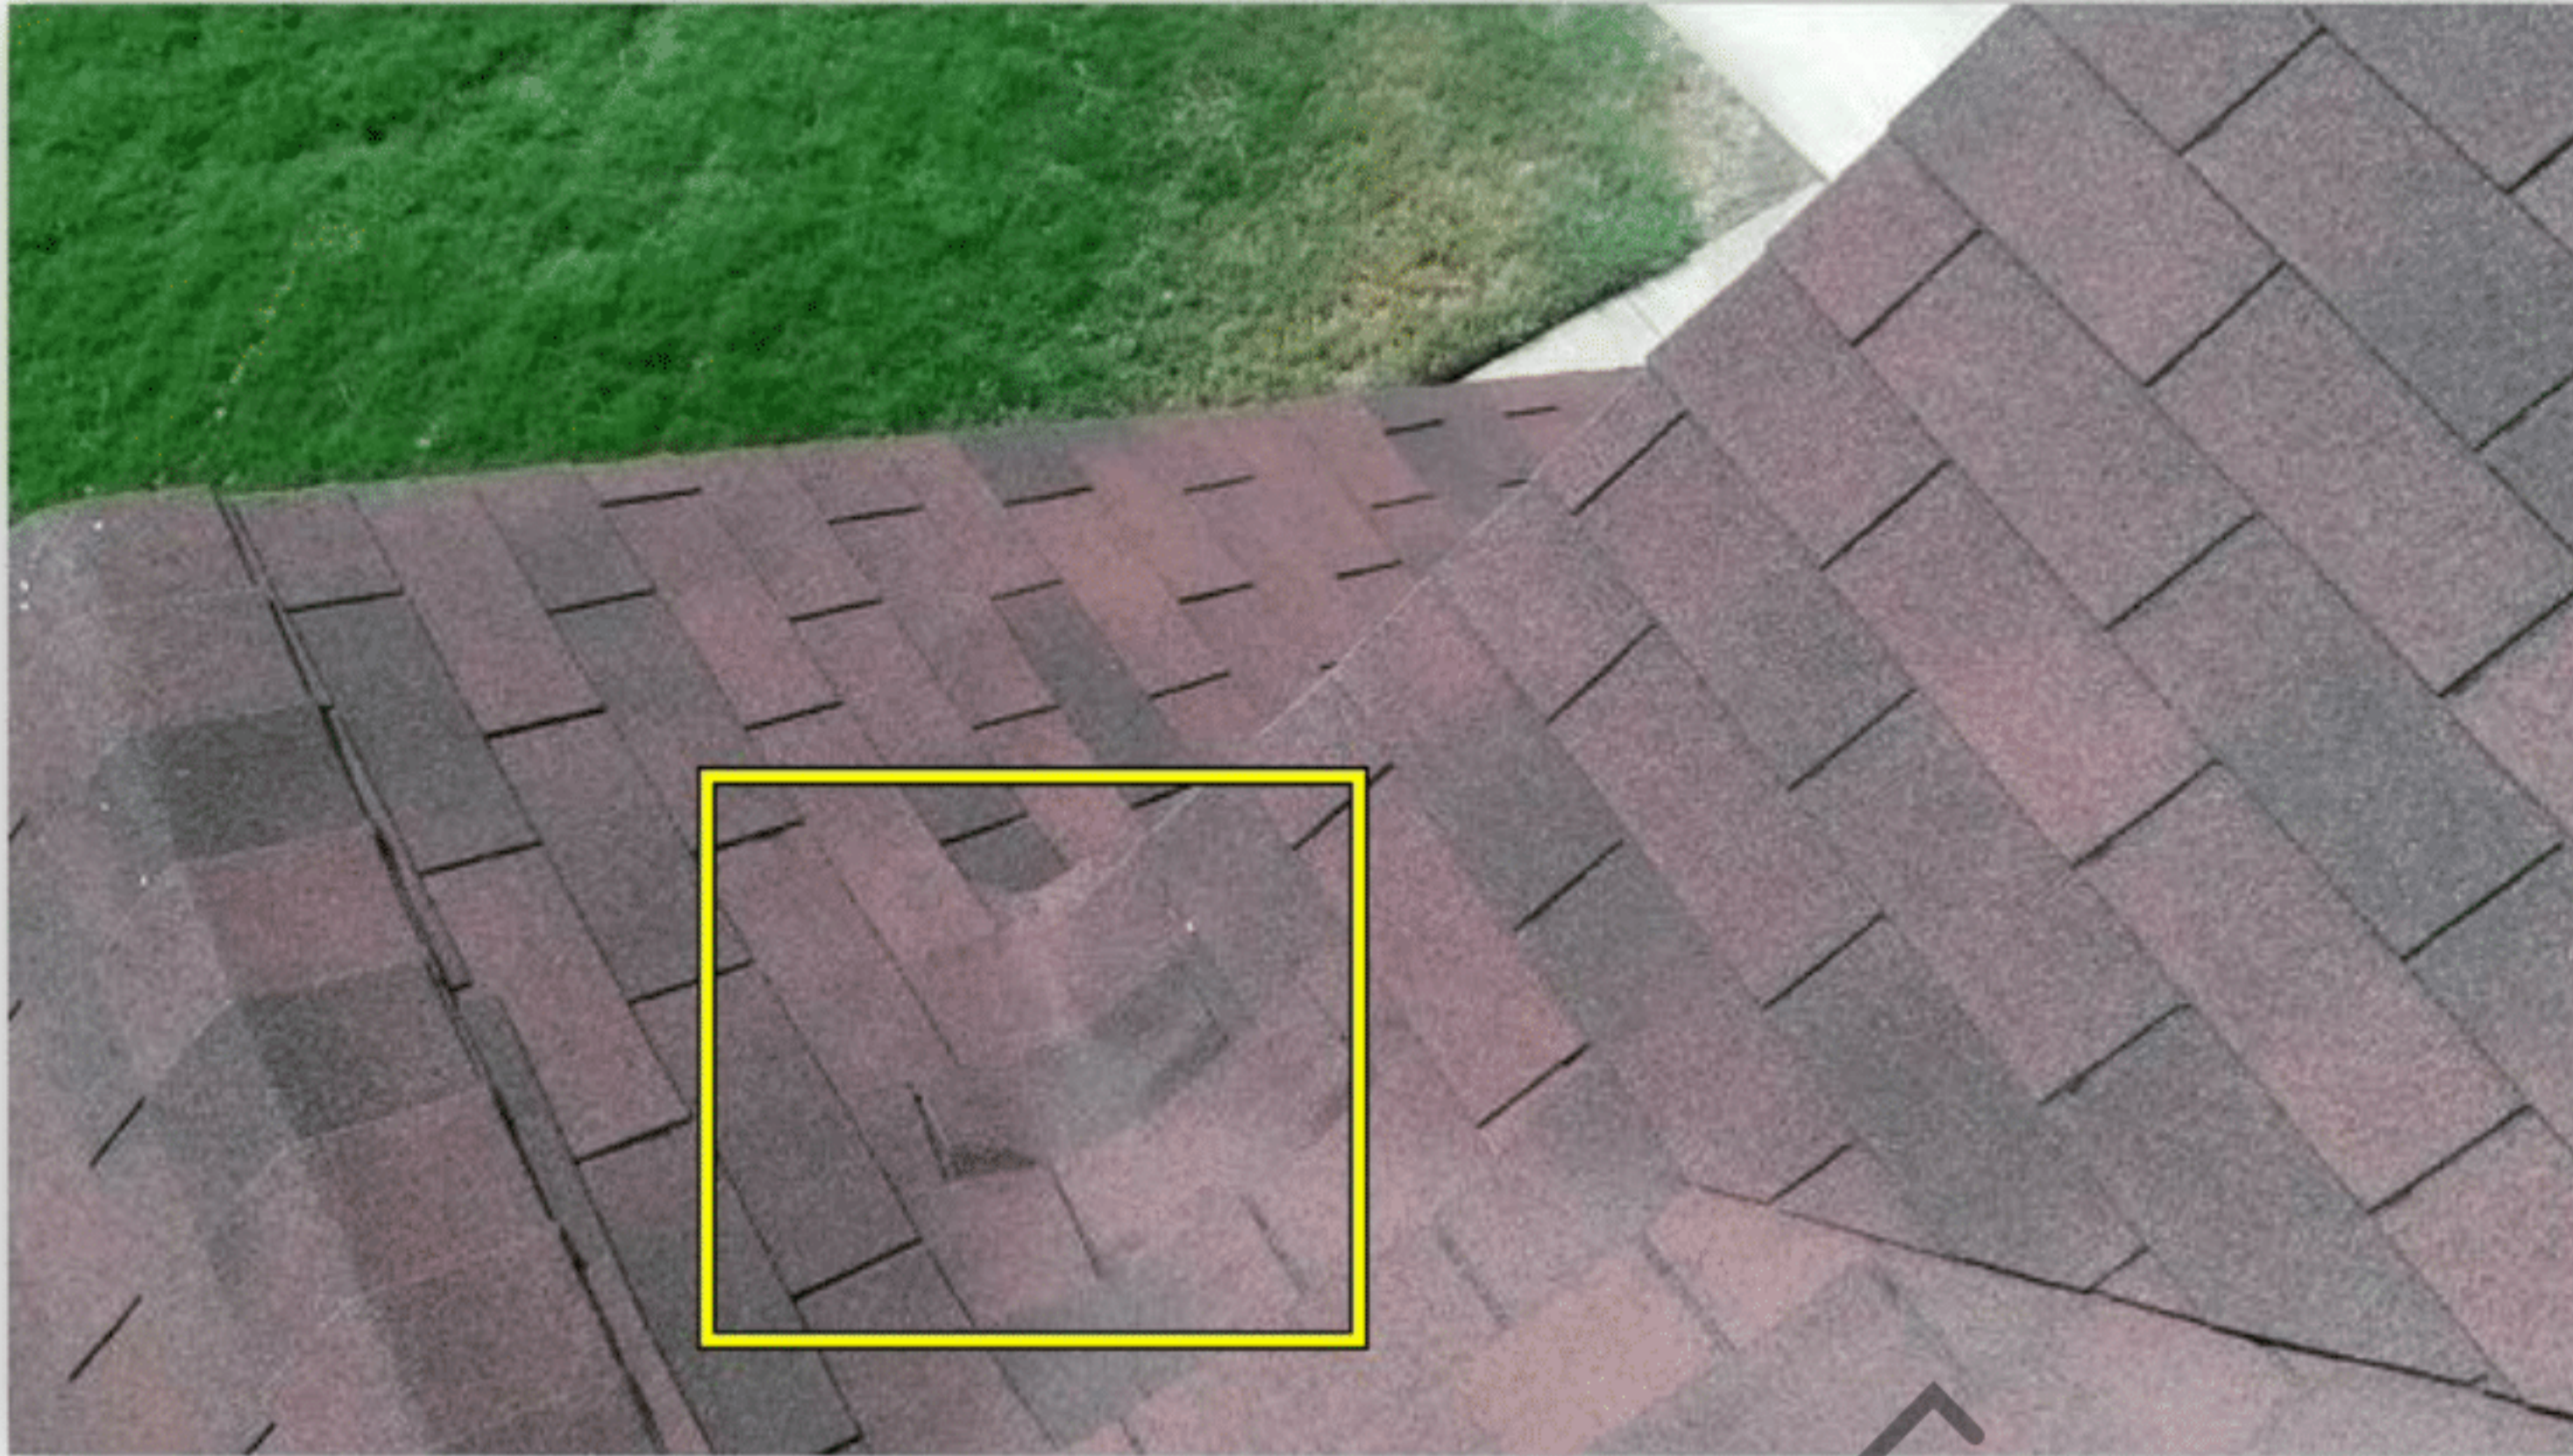
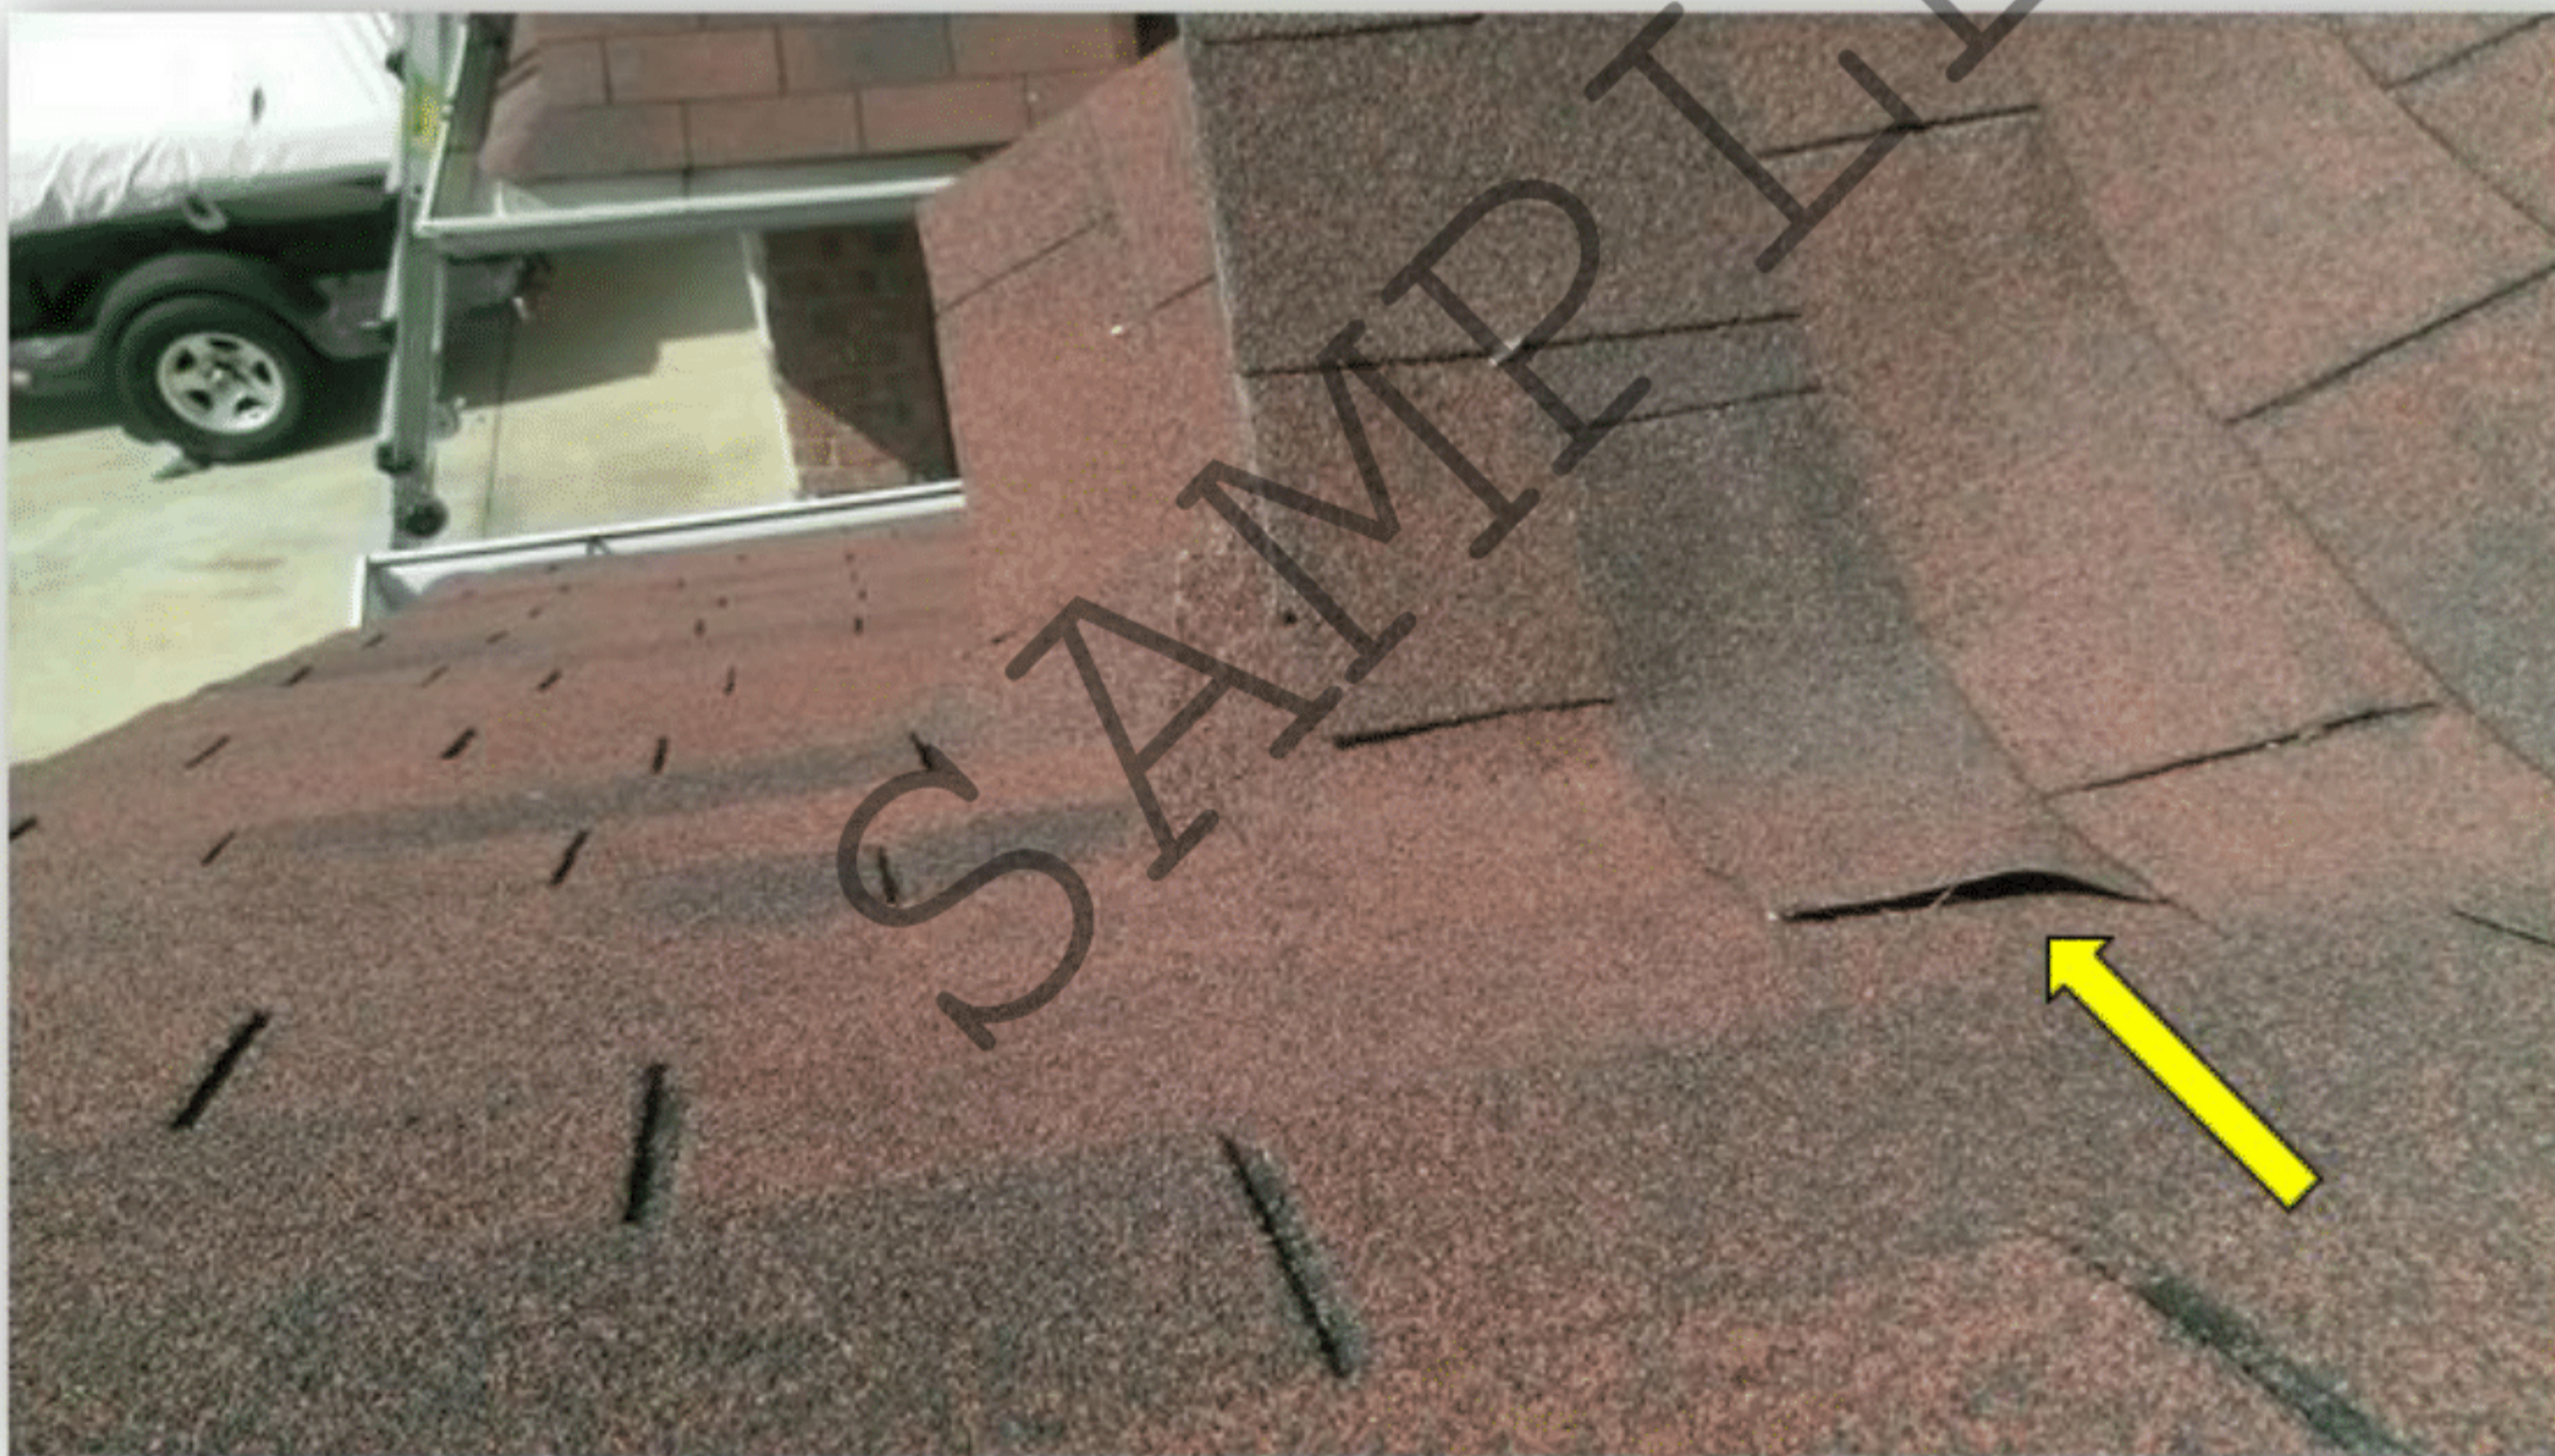
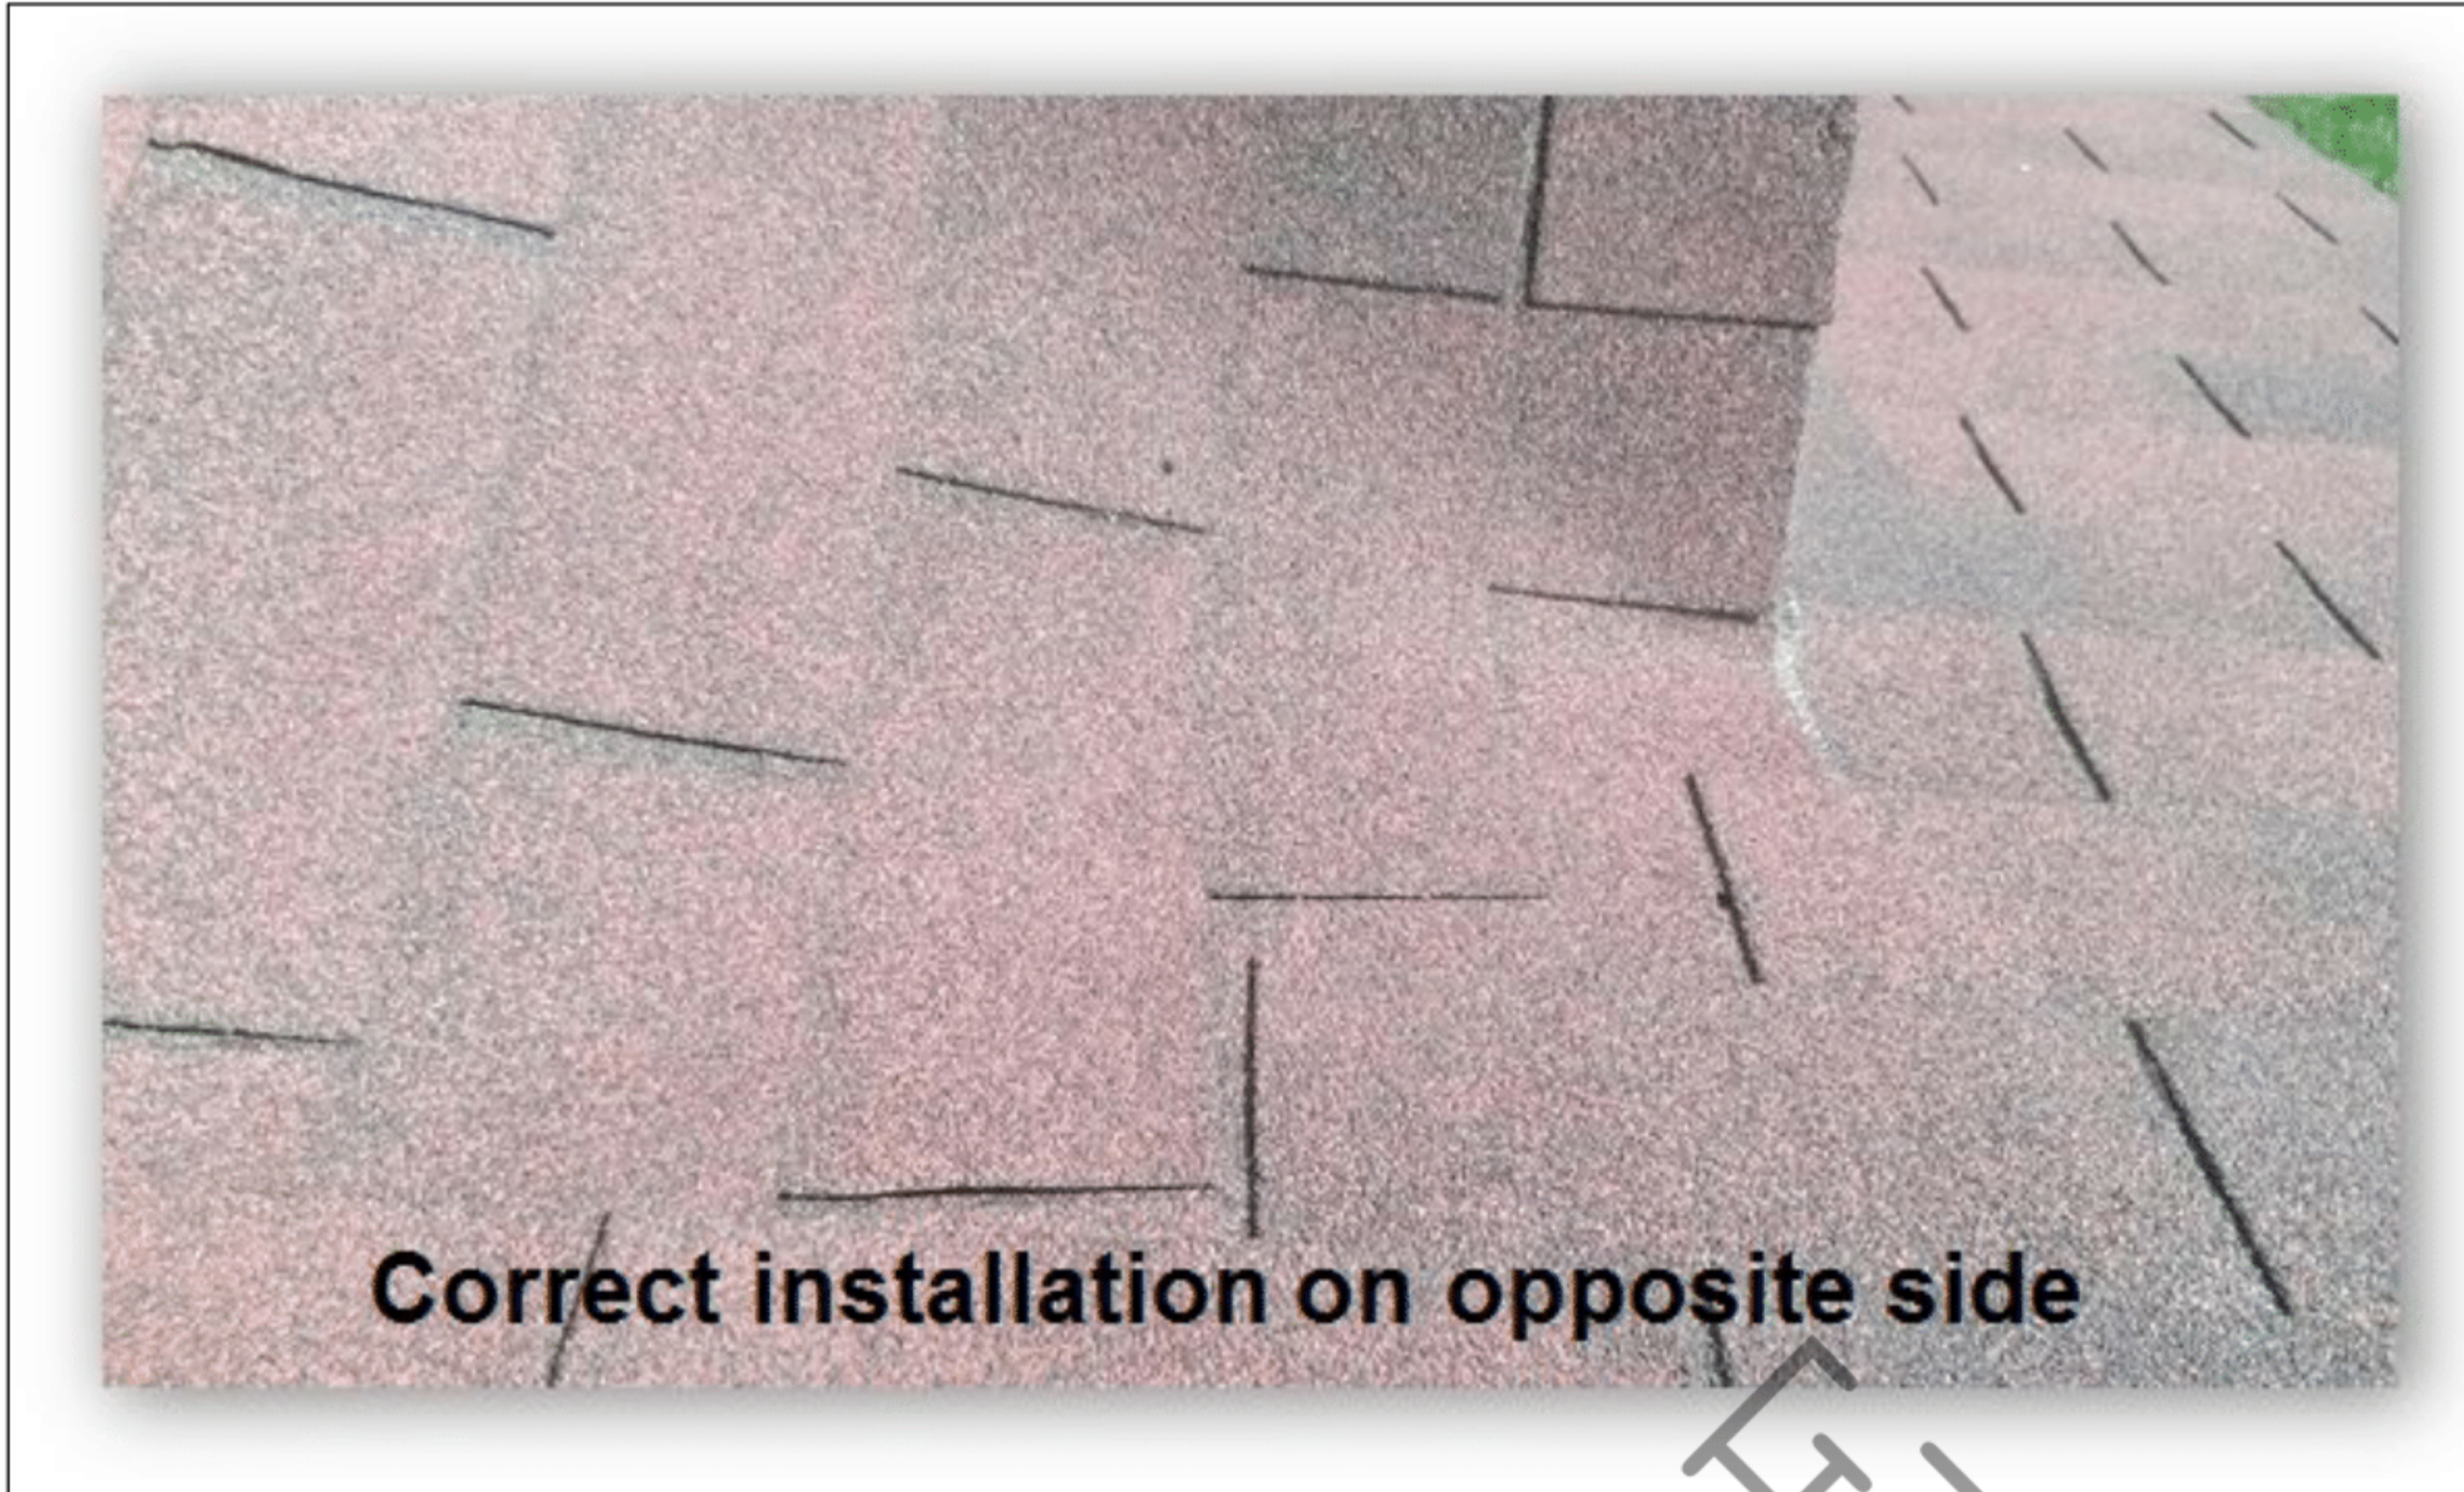
The water staining in the ceiling in the front right bedroom and it's closet is likely related to this installation deficiency in the shingles. The issue is a minor repair and should be performed by a qualified roofing contractor. The shingles in the indicated area are not properly installed and are allowing moisture to penetrate to the under-laying felt. The design and slope of the area is such that standing moisture is able to seep through the felt under laying and intrude on the roof decking where it will run downward to the nearest seam and begin dripping in the attic. Corresponding area in the attic was obstructed by personal belongings. The final photo in this comment shows the opposite side of the roof with a similar design and a more appropriate shingle installation.

The ceiling materials that are marked with water stains appear to be dry and could be painted rather than replacing the materials. - "[§535.228 \(e,f\)\(2\)](#)"
