Anchor Inspection Group
972-655-9601
heath@anchorinspectiongroup.com

Summary

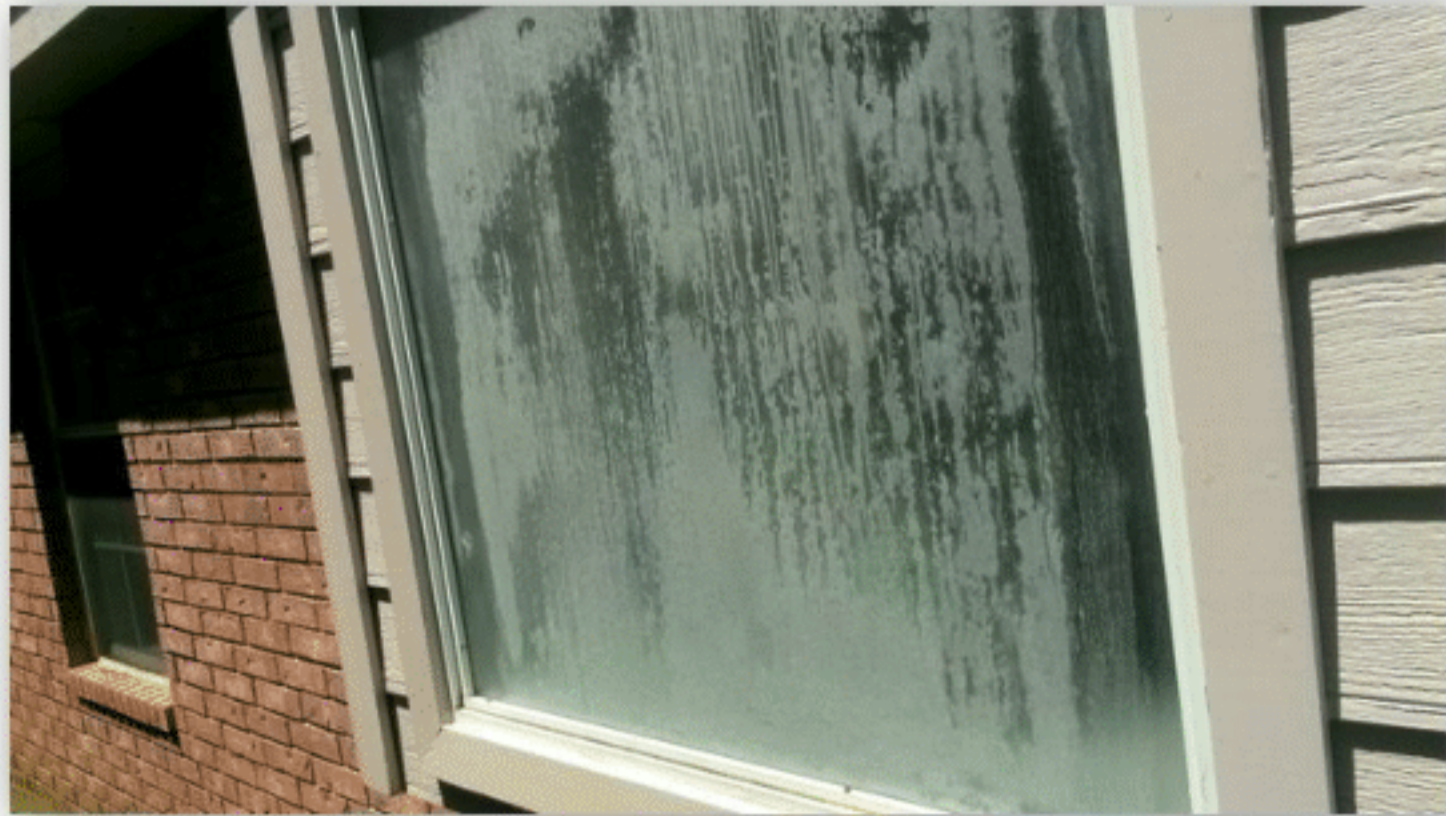
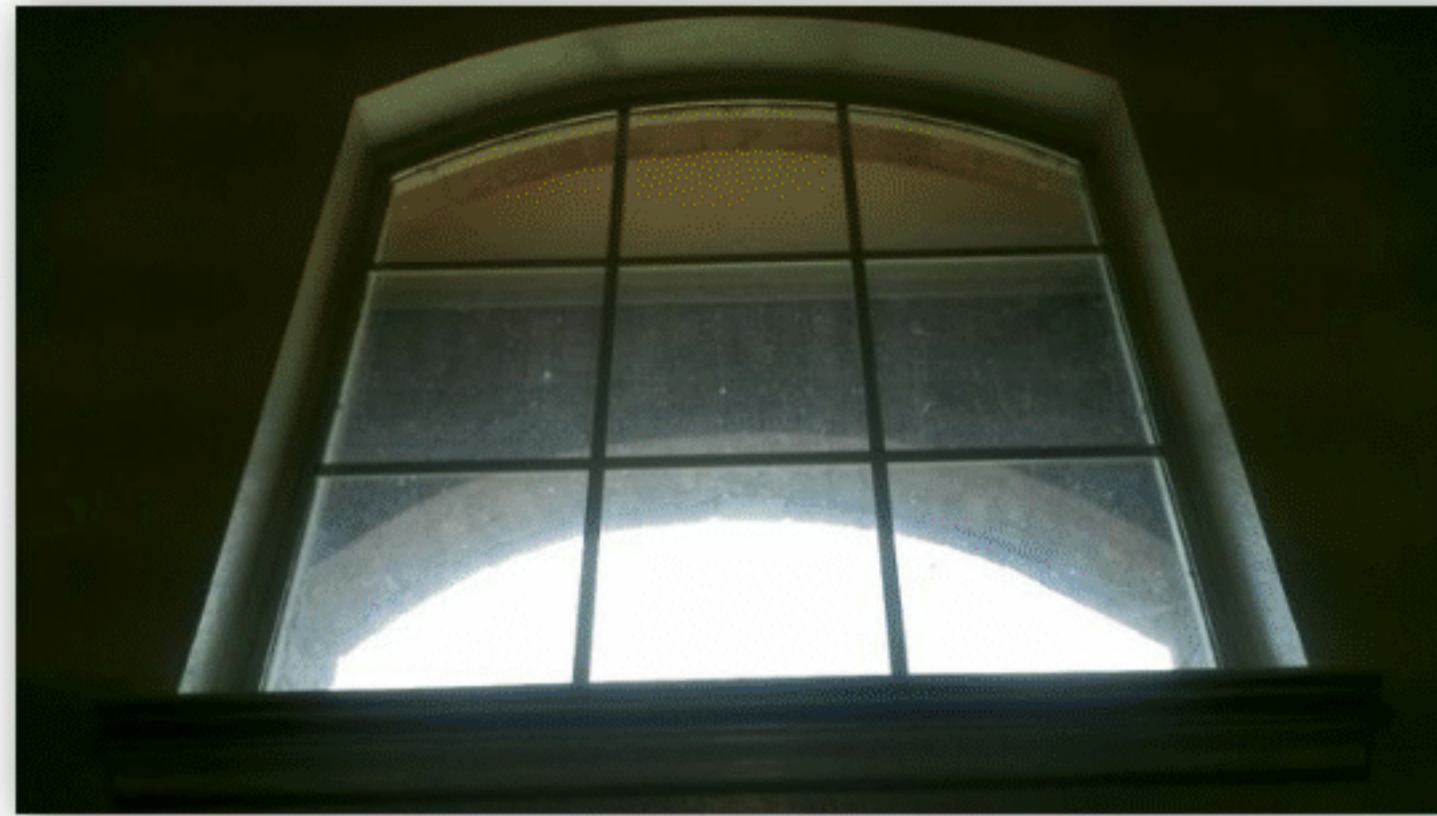
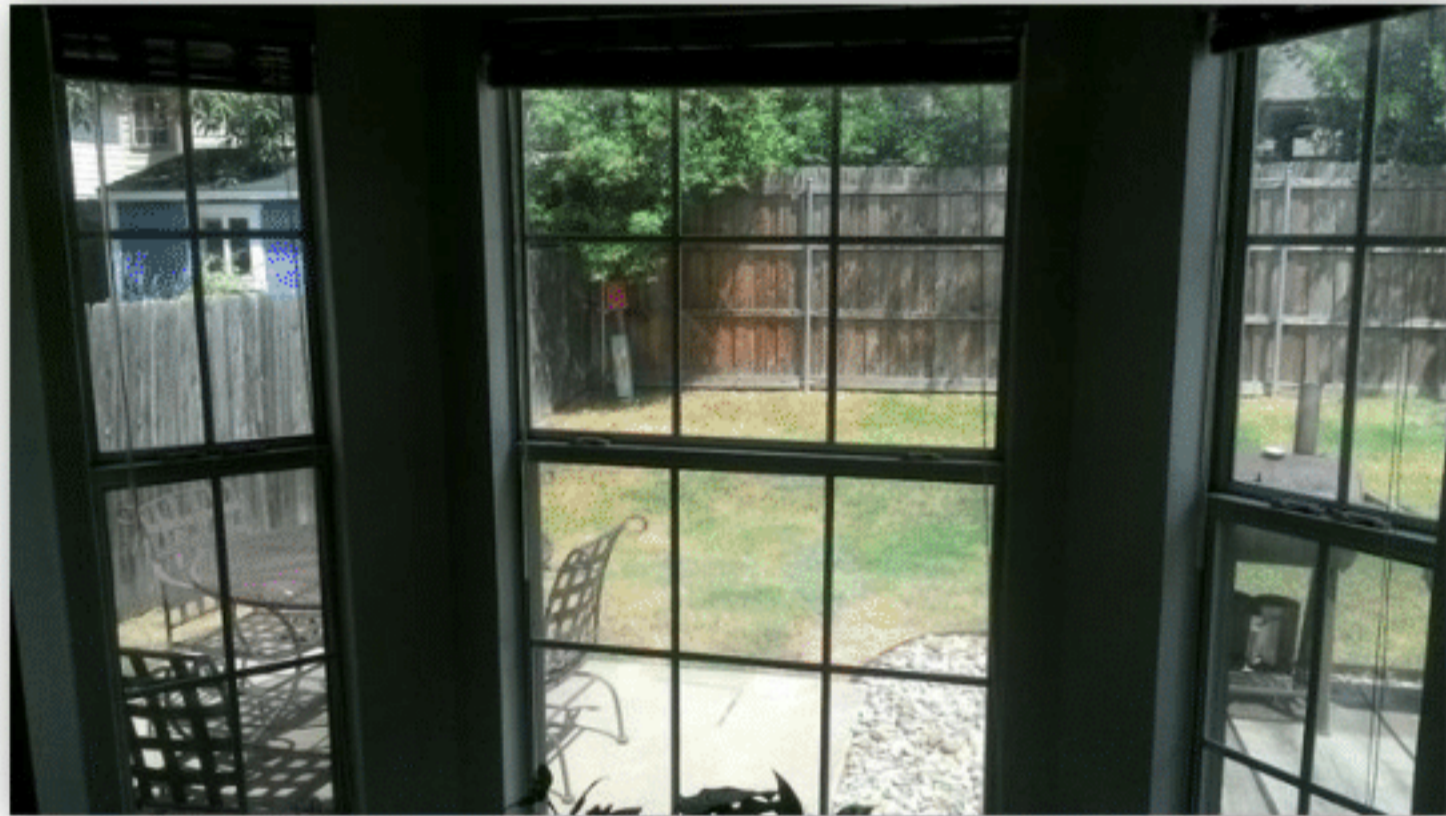
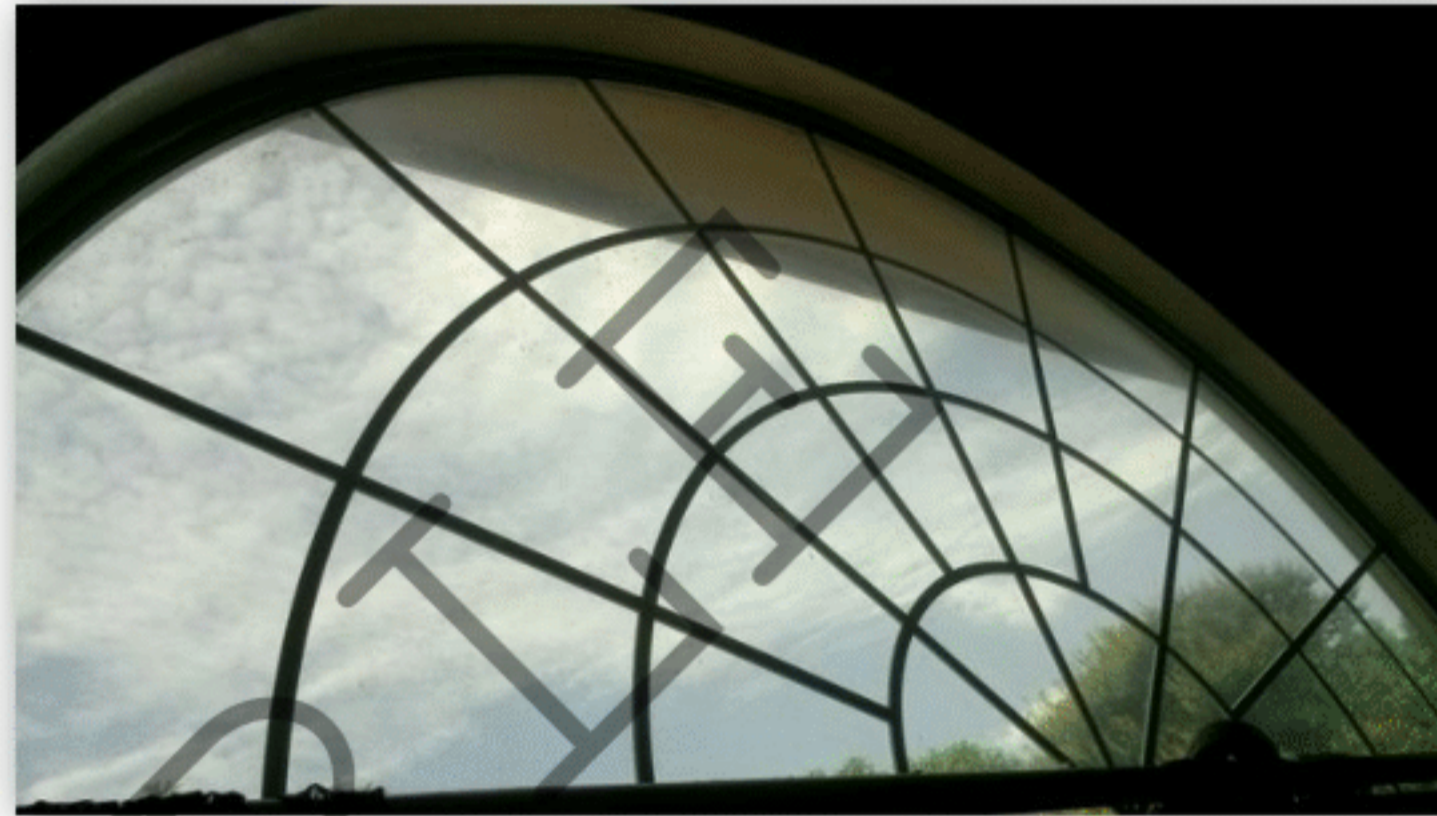
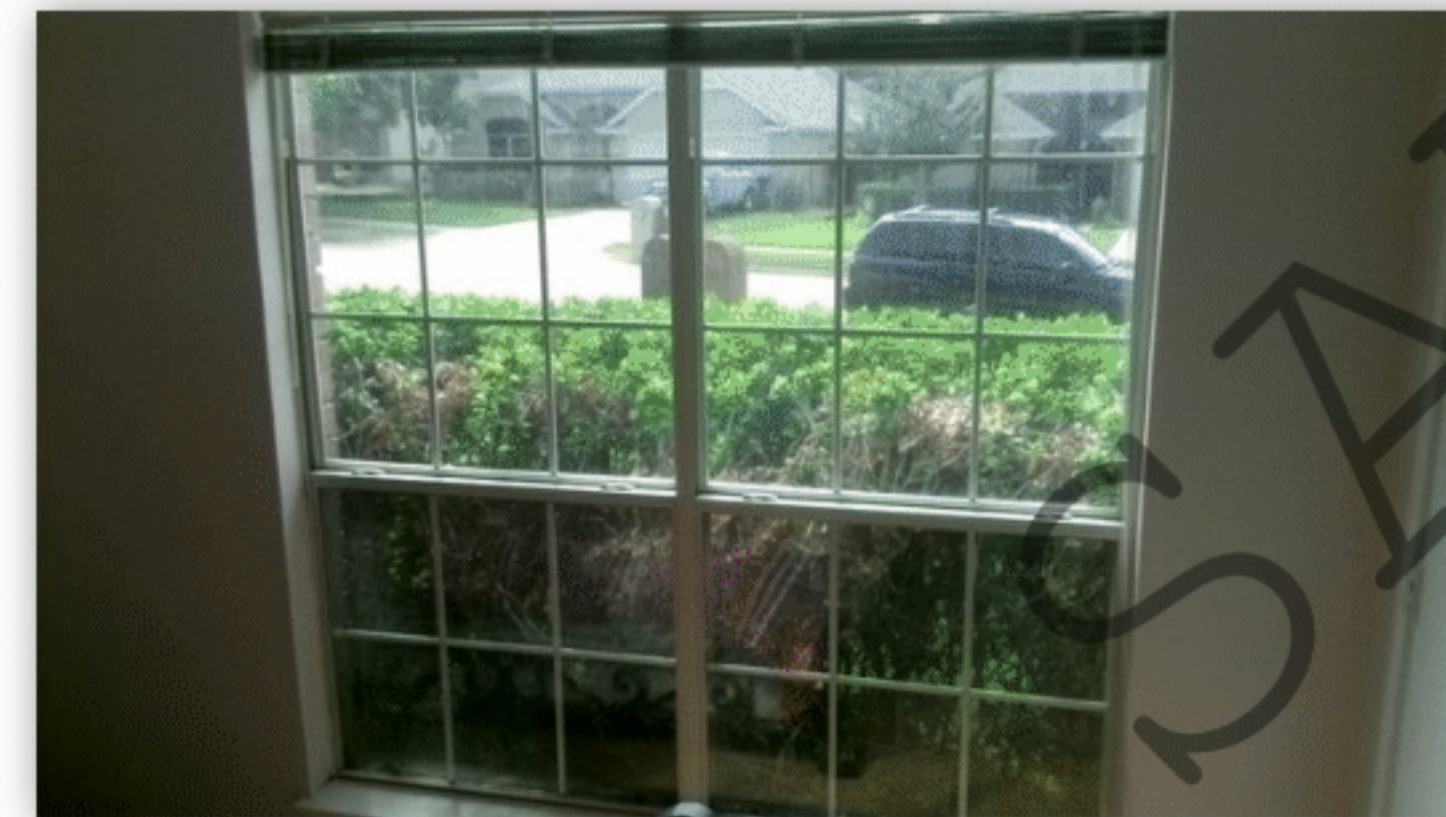
One or more dual paned thermal windows have seals that are breached at: [Multiple locations]; -Recommend obtaining an evaluative estimate for replacement or repair before closing. While some may last much longer, thermal windows typically have a 10-15 year life expectancy before some of the seals wear enough to cause observable conditions inside the panes. "[§535.228 \(g\)\(1\)\(B\)](#)"

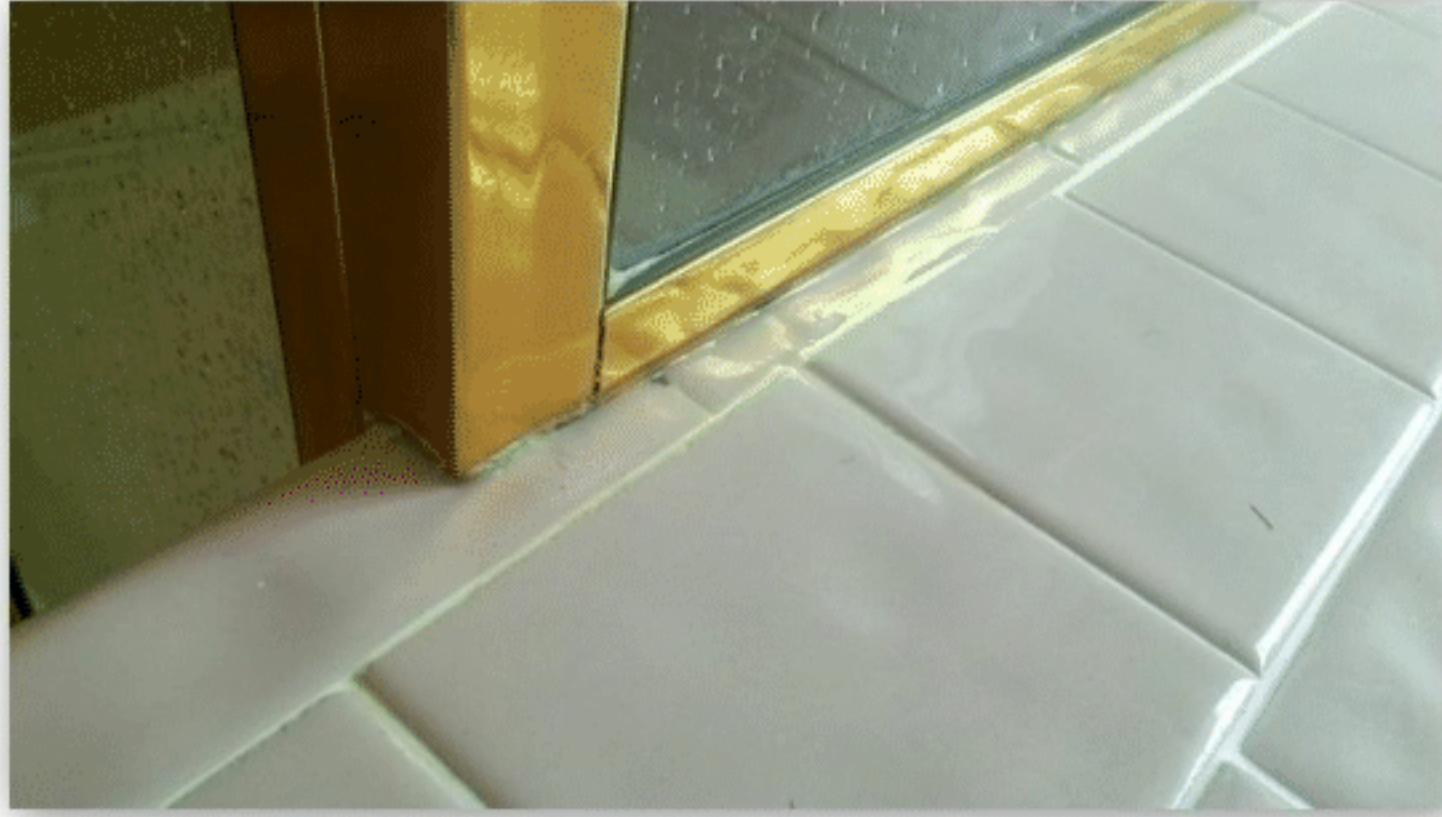
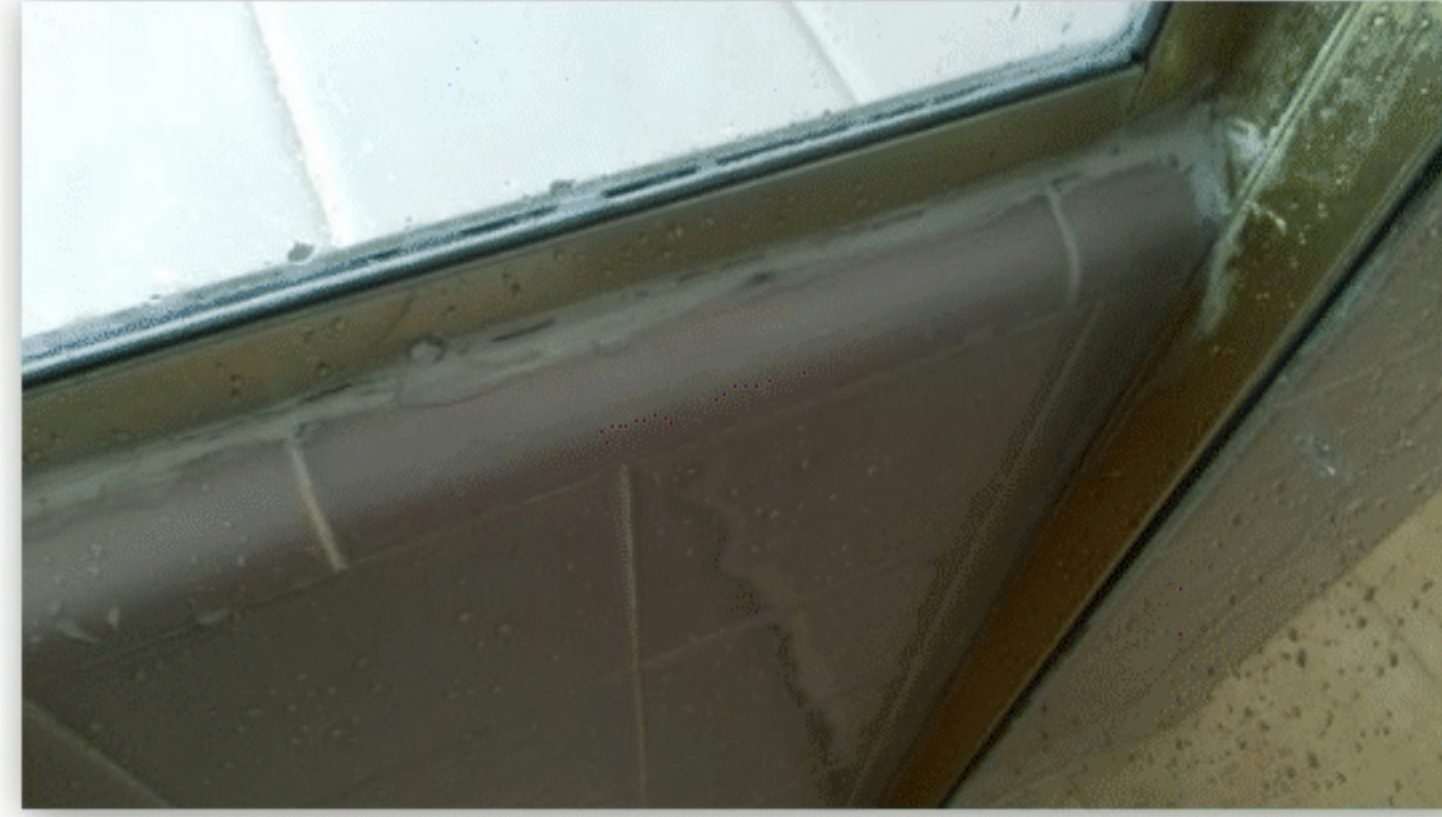
Shower enclosure is leaking at: Master Bathroom Shower. Recommend repair to the caulking on the inside of the enclosure. - "[§535.231 \(a\)\(2\)\(E\)\(viii\)](#)"

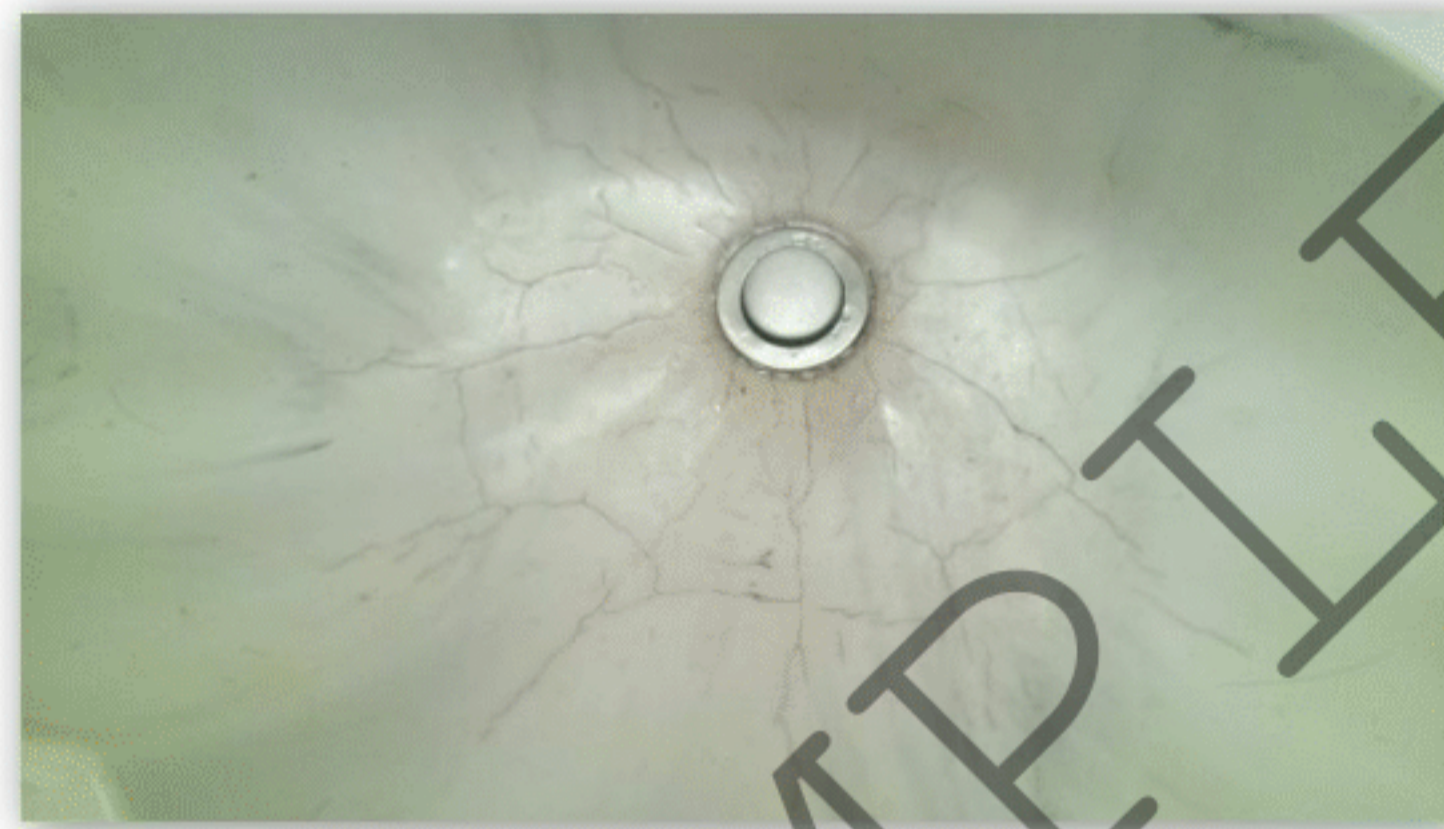
Damage to finish at: Hall Bathroom (1st Floor) Sink - "[§535.231 \(a\)\(2\)\(E\)\(viii\)](#)"

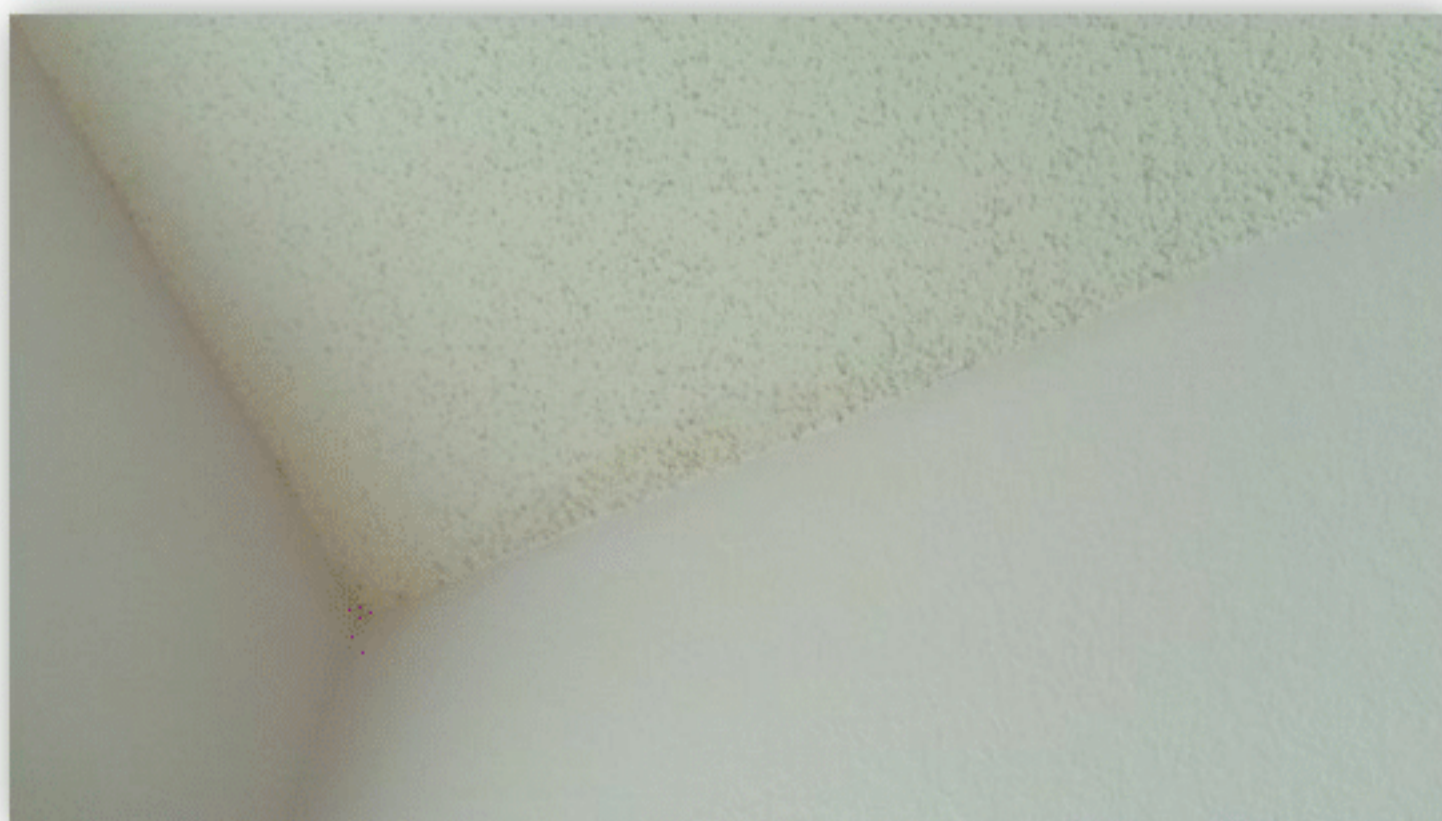
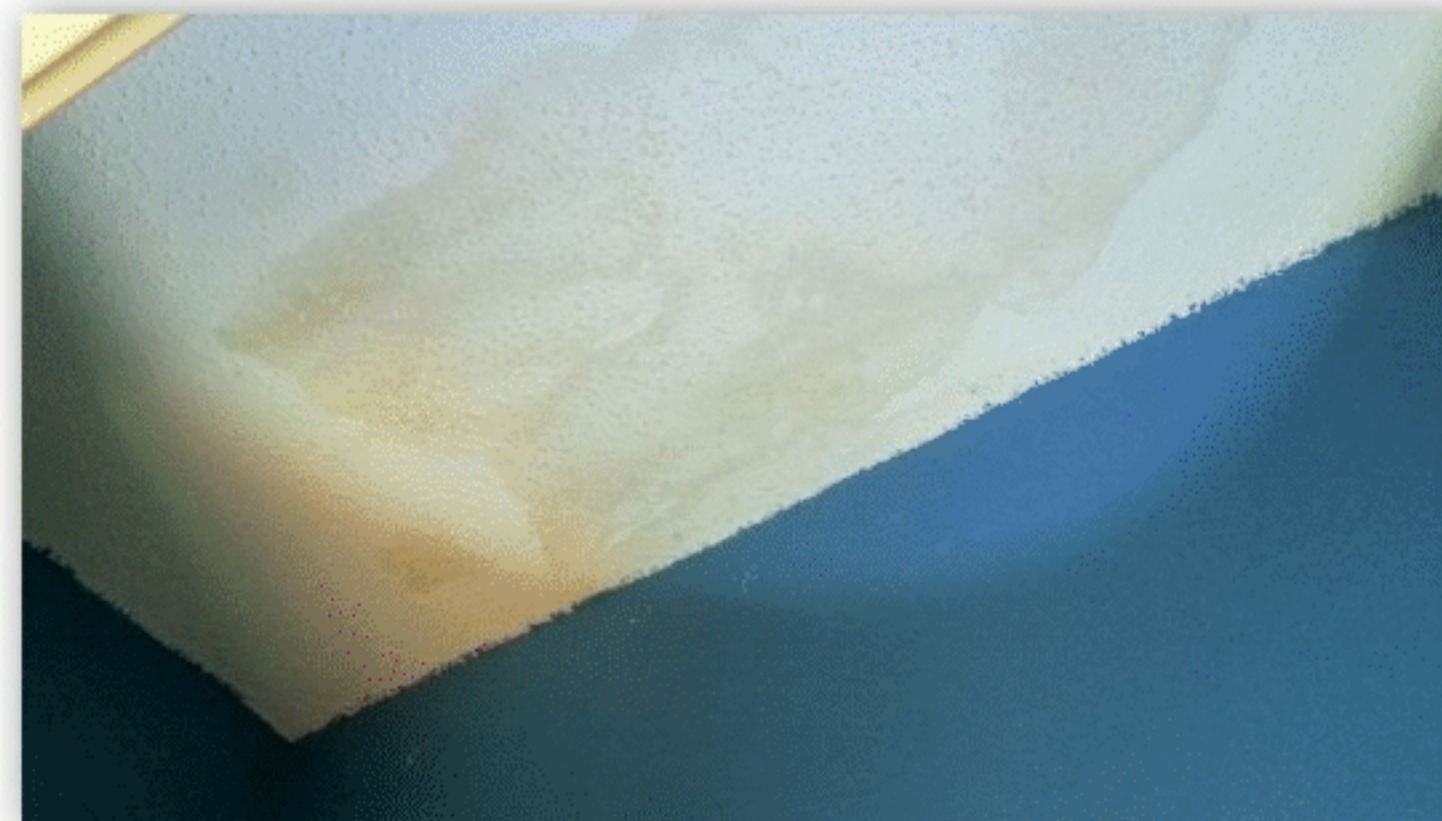
Ceiling has water staining at: [Front right bedroom] See the section: "Roof Covering Materials" for additional details regarding the moisture penetration. - "[§535.228 \(e\)\(2\)\(B\)](#)"
