I. STRUCTURAL SYSTEMS

A. Foundations

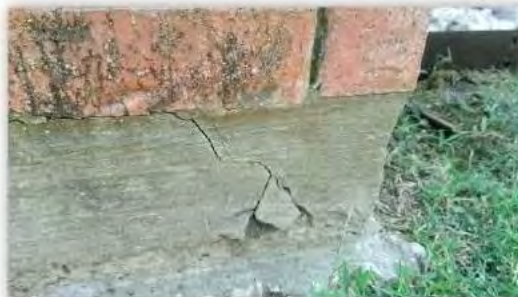
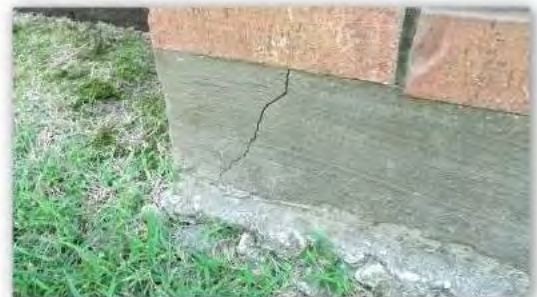
Corner deterioration on slab homes is common and not a structural threat in most cases. In some cases, the bricks above the corner may experience settling if the foundation corner contains enough deterioration. To avoid this, simply patch the corner with a mortar compound. - "§535.228 (a)(4)(A)"

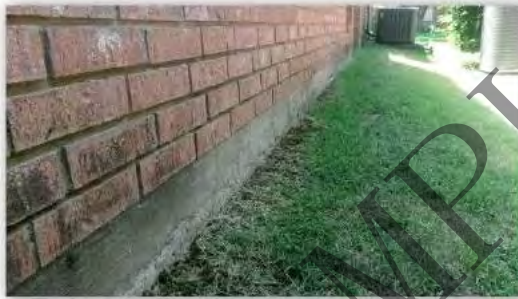
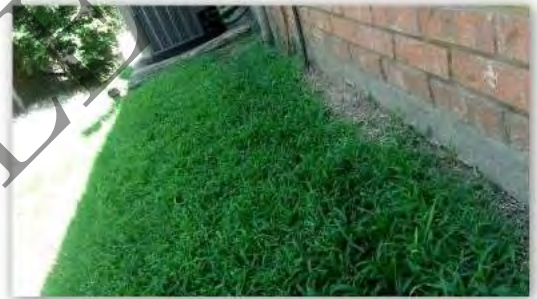
Water shed from the roof has caused trenching near the structure. Trenching can impact the stability of the foundation due to standing water near the foundation in some cases. The grading should have a consistent slight slope away from the structure for several feet. A recommended solution is the installation of a gutter system with appropriate downspout placement. - "[§535.228 \(b\)\(1\)](#)"

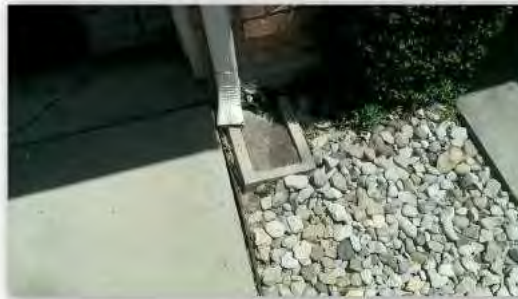
Downspouts dispensing water too close to the structure. It's recommended that the downspout be extended 18"-30" from the structure or an adequate alternative method applied. [Front, towards the center of the structure.(When facing the front)] - "[§535.228 \(b\)\(1\)\(C\)](#)"

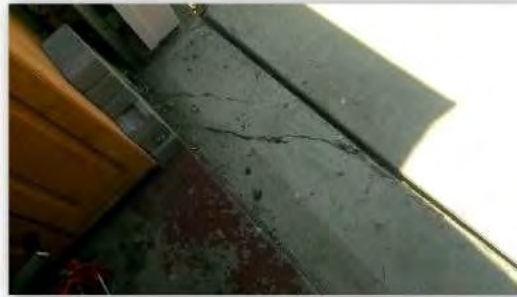
Crack(s) in walkway in one or more locations. - "[§535.228 \(b\)\(1\)](#)"

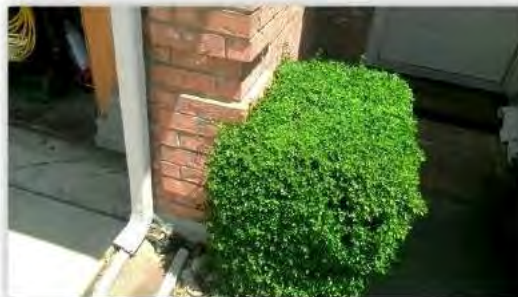
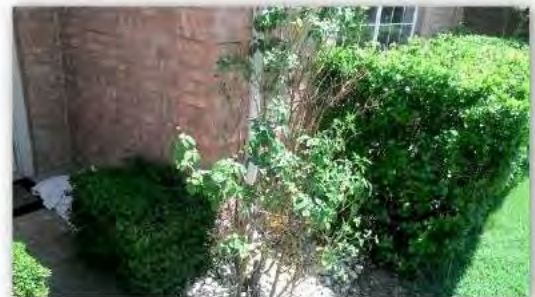
Foliage/Planters should not be directly adjacent to the structure. Foliage in contact with the structure provides easy access for moisture and pests, and conceals evidence of pest intrusion. [Multiple locations] - *Homeowner Tip

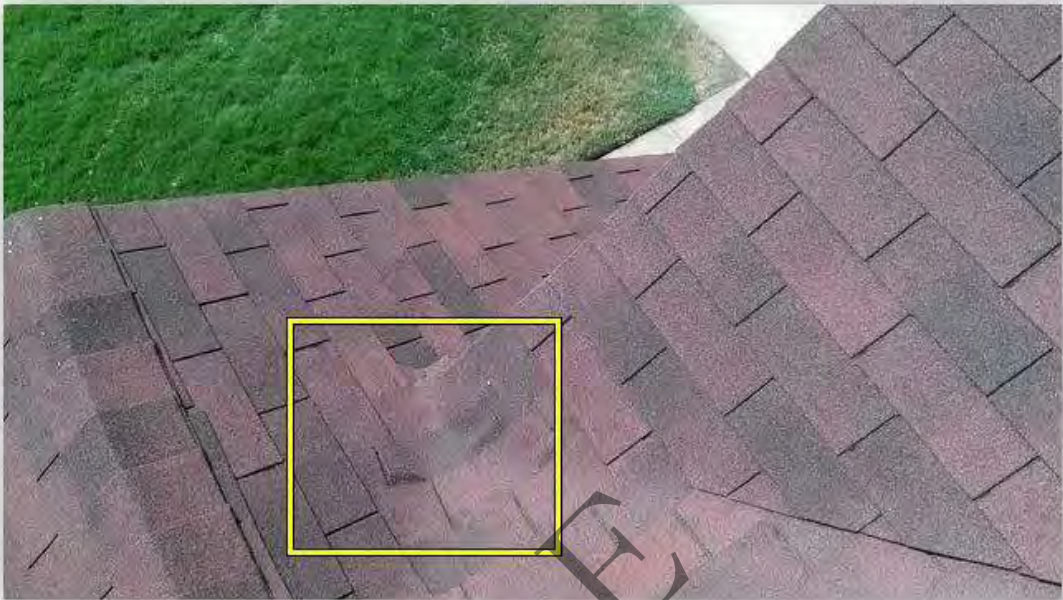
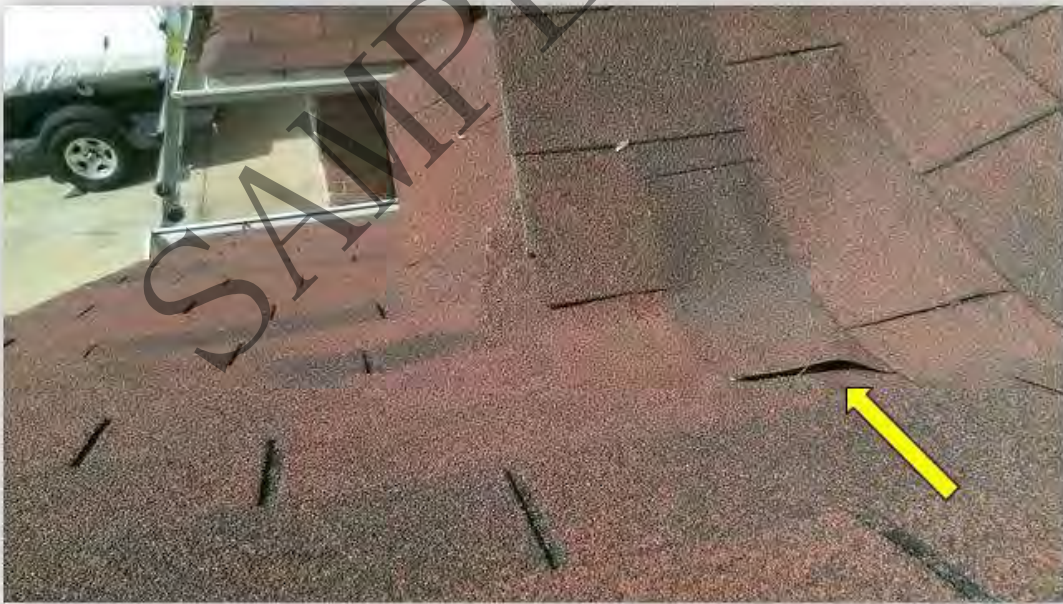
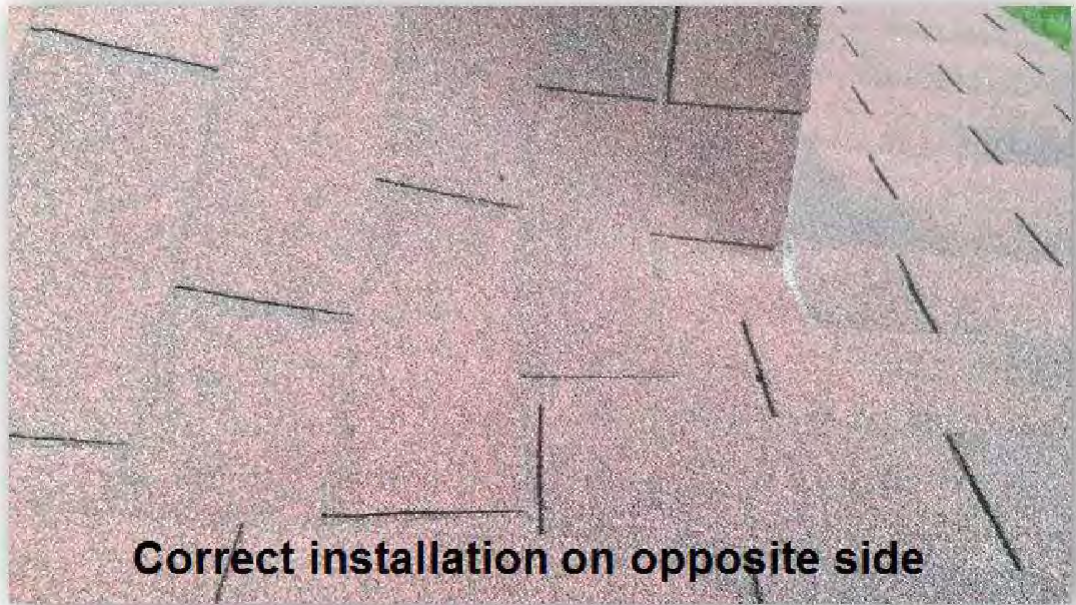
The water staining in the ceiling in the front right bedroom and it's closet is likely related to this installation deficiency in the shingles. The issue is a minor repair and should be performed by a qualified roofing contractor. The shingles in the indicated area are not properly installed and are allowing moisture to penetrate to the under-laying felt. The design and slope of the area is such that standing moisture is able to seep through the felt under laying and intrude on the roof decking where it will run downward to the nearest seam and begin dripping in the attic. Corresponding area in the attic was obstructed by personal belongings. The final photo in this comment shows the opposite side of the roof with a similar design and a more appropriate shingle installation.

The ceiling materials that are marked with water stains appear to be dry and could be painted rather than replacing the materials. - "[§535.228 \(e.f\)\(2\)](#)"

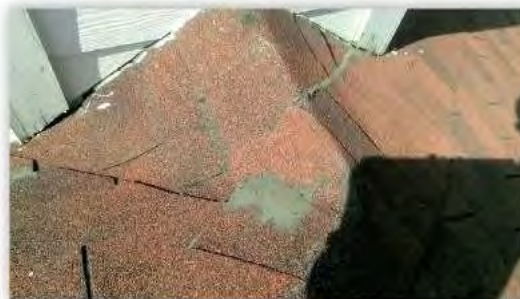
Signs of repairs near the chimney cricket. No signs of moisture penetration observed on the interior. - "[§535.228 \(c\)\(3\)](#)"

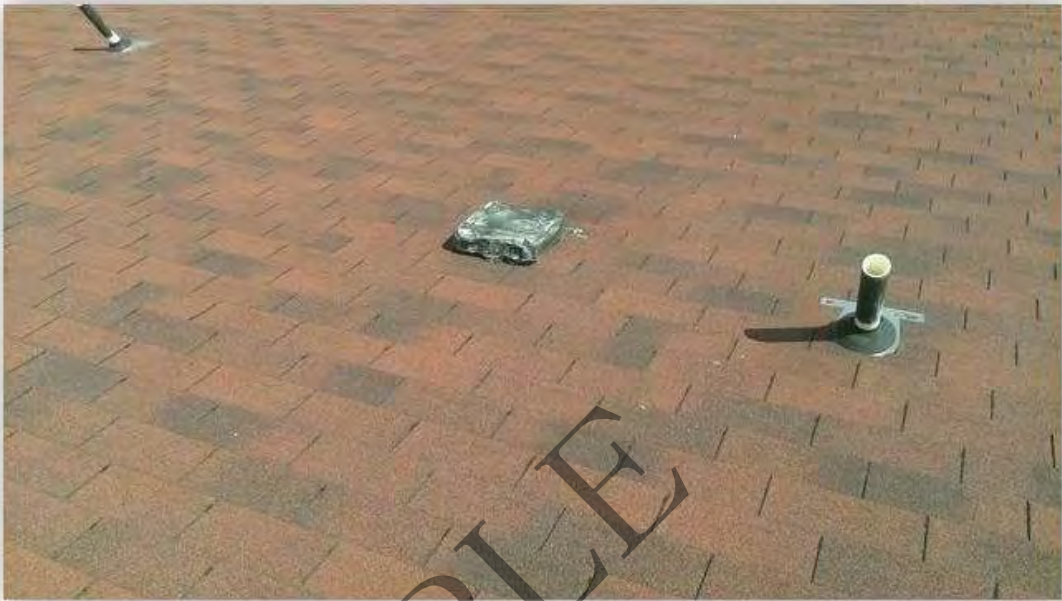
Flue/Vent cover has physical damage. The component appears to be functioning as intended. - "[§535.228 \(c\)\(3\)](#)"

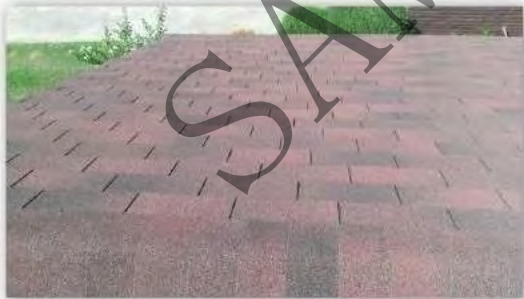
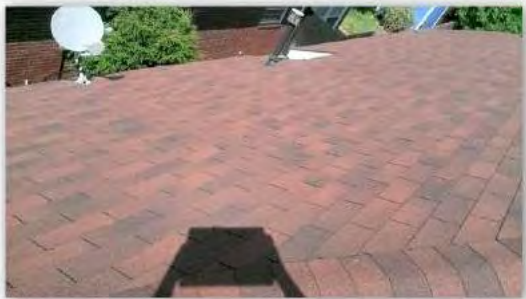
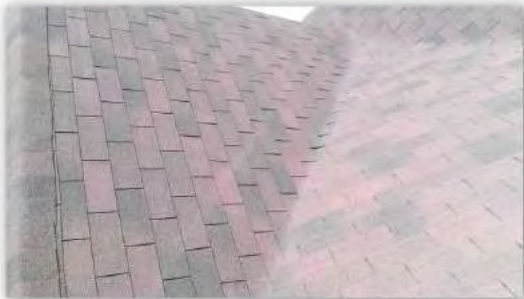
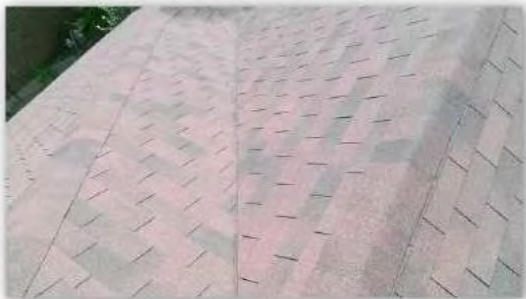
General shingle condition photos. - "[§535.228 \(c\)\(3\)](#)"

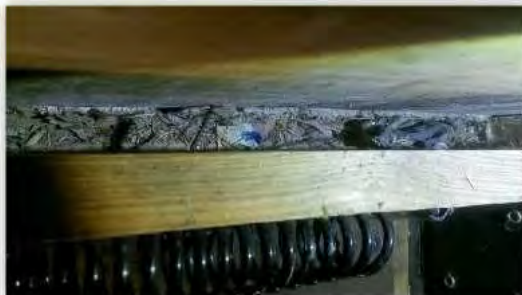
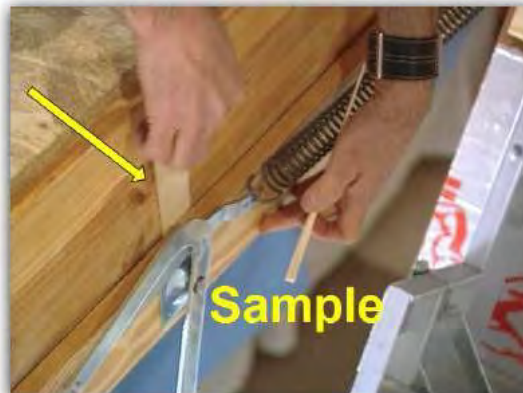
The recommended spacers/shims are missing from the attic hatch installation. - "[§535.228 \(d\)\(2\)\(A\)](#)"

Shims serve as a spacer in the hatch installation. The manufacturer usually includes shims with the installation materials. In some cases, additional shims may be needed.

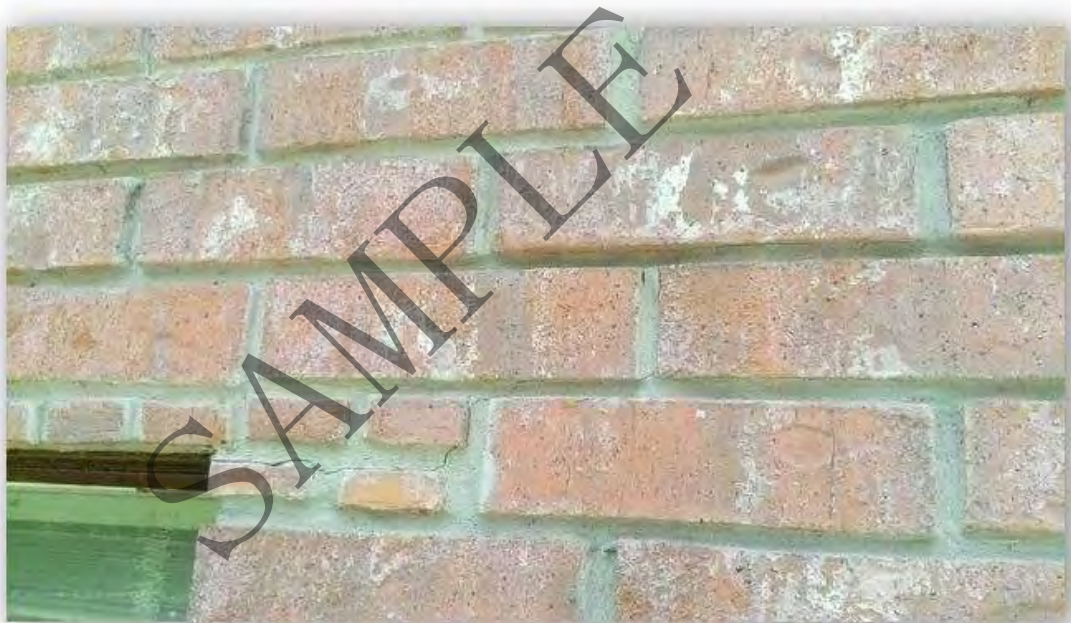
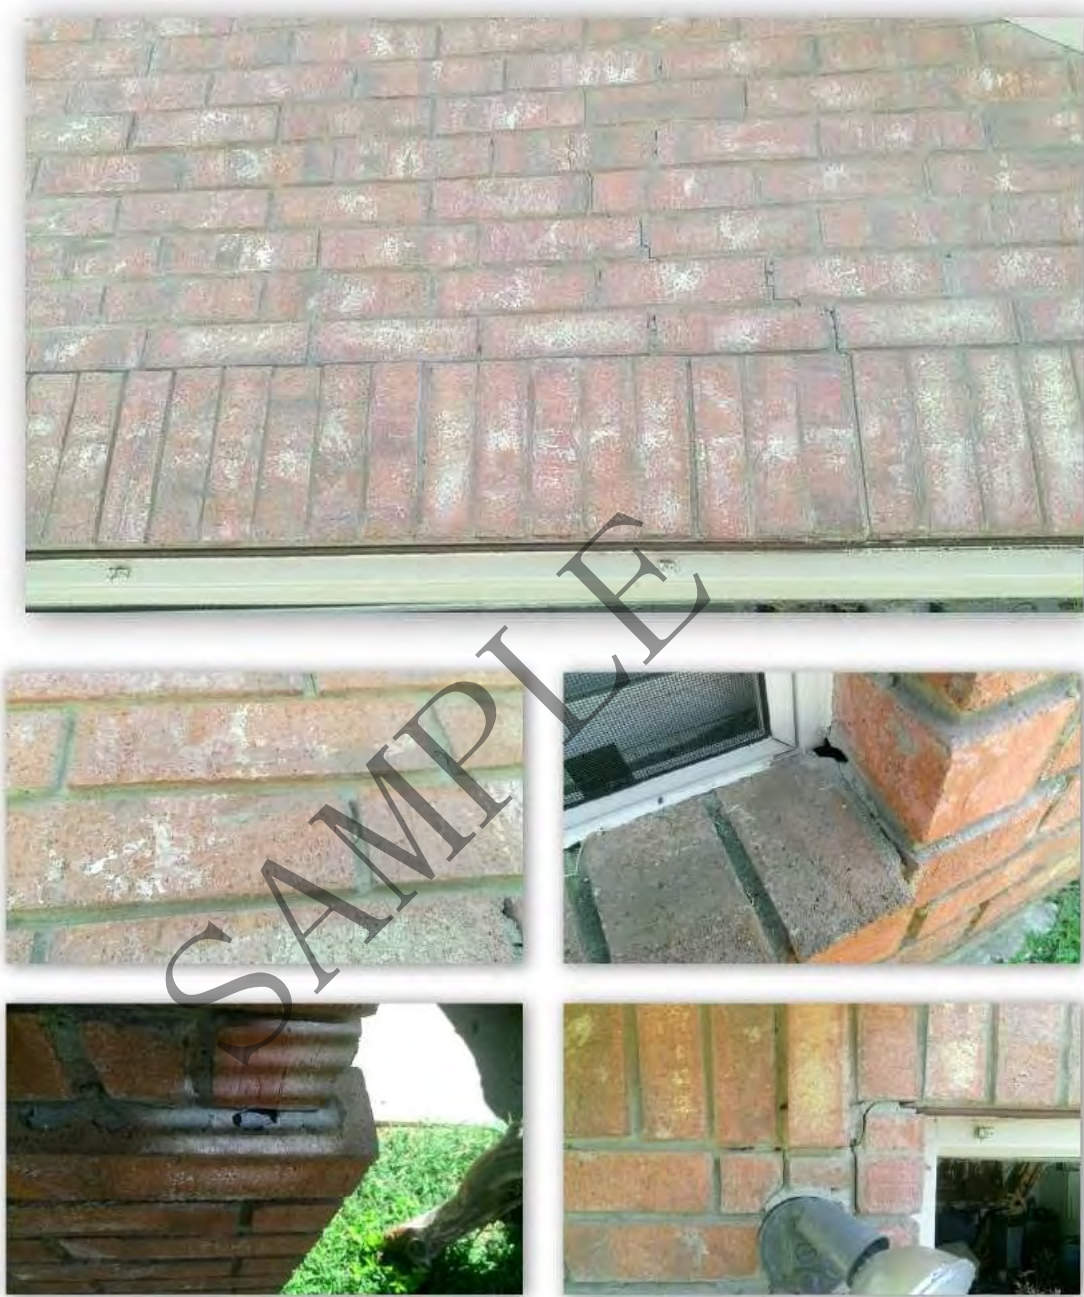
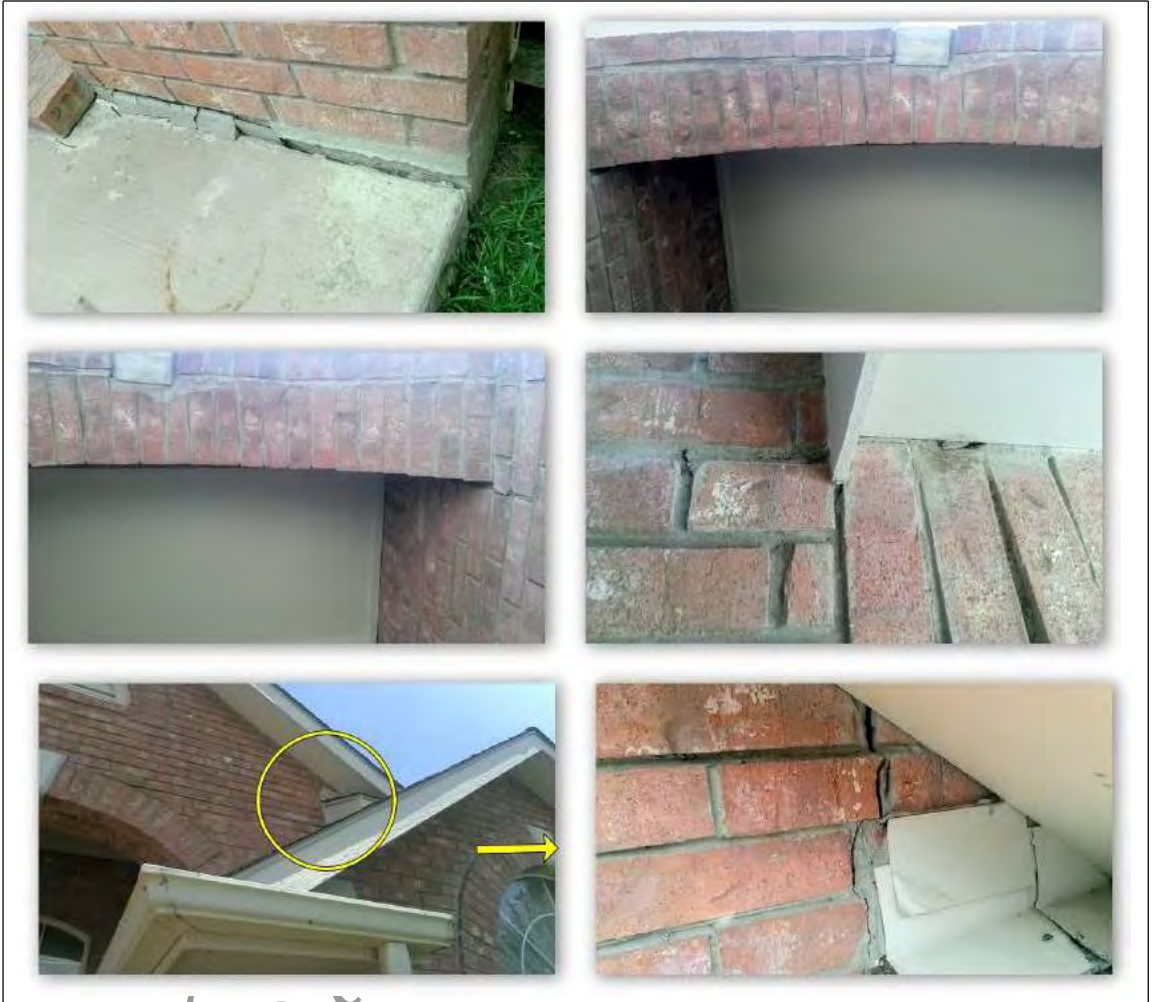
Mortar separation/deterioration/missing and cracking in adjacent masonry. In most cases, mortar deterioration is a common maintenance item that should be repaired periodically.[Multiple locations] - "[§535.228 \(f\)\(2\)\(D\)](#)"

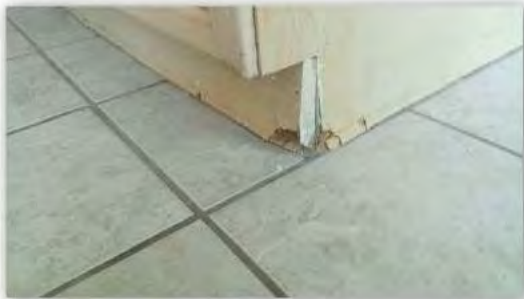
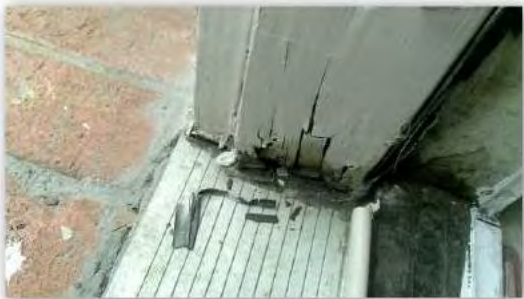
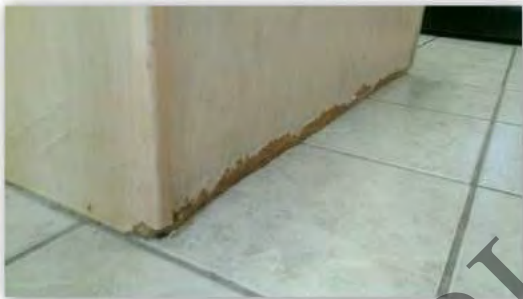
Damage to trim/fascia/wood in one or more locations.[Multiple locations] - "[§535.228 \(f\)\(2\)\(E\)\(iii\)](#)"

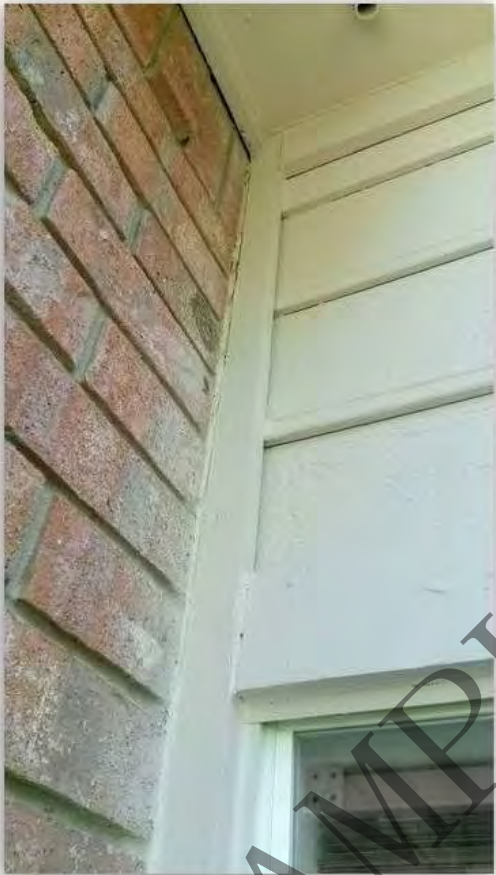
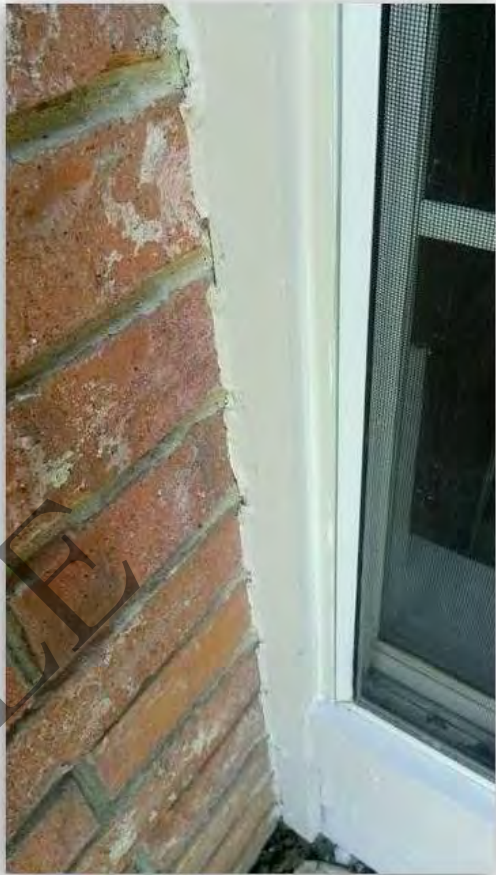
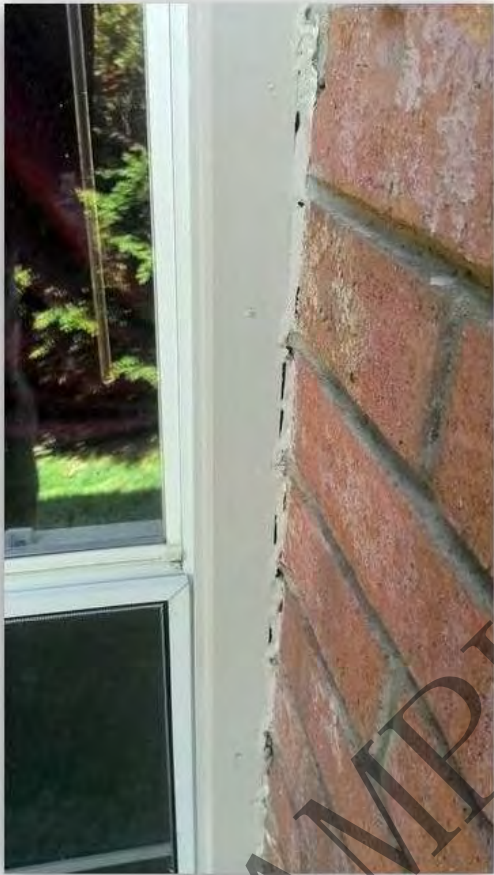
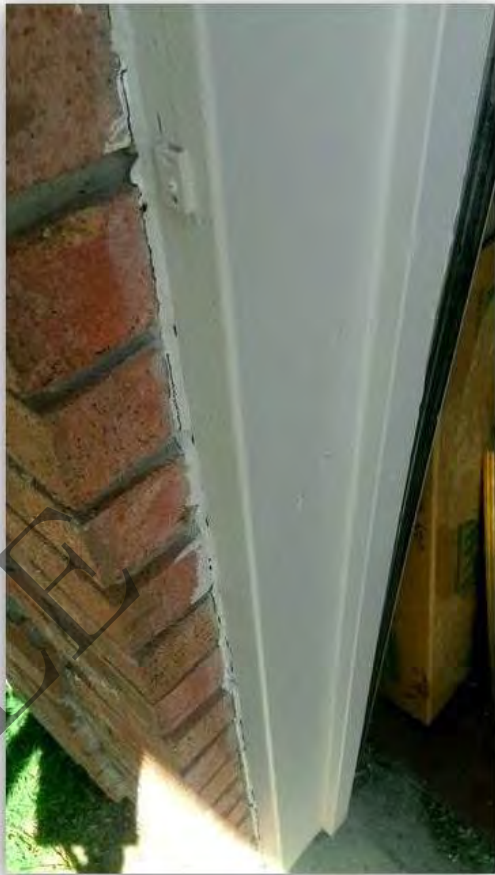
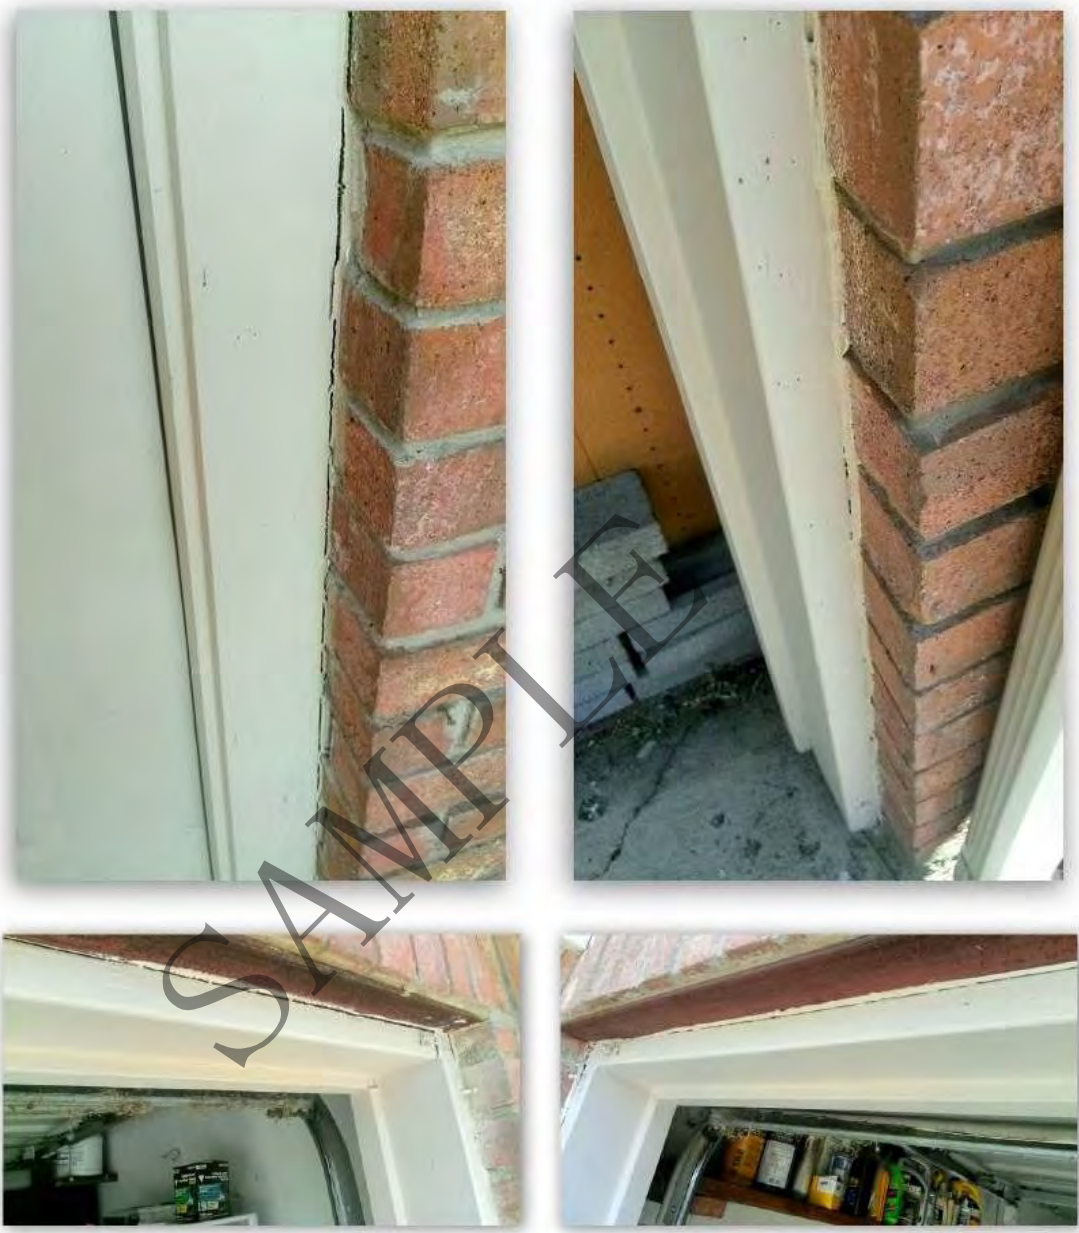
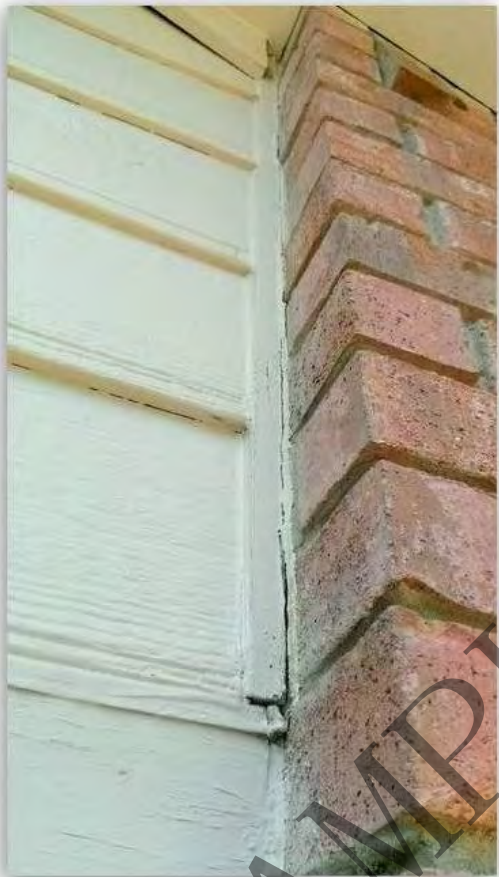
Caulking is in need of repair or is missing. In many cases, this is a regular maintenance item and should be repaired as desired. [Multiple locations] - "[§535.228 \(f\)\(2\)\(D\)](#)"

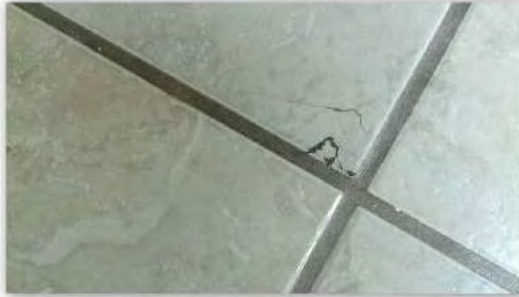
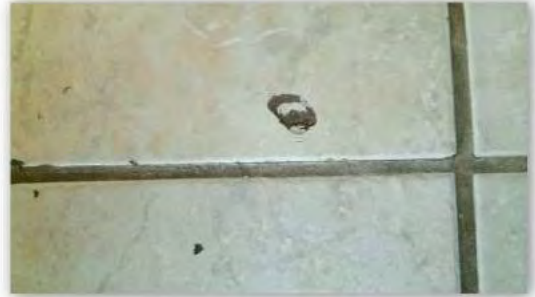
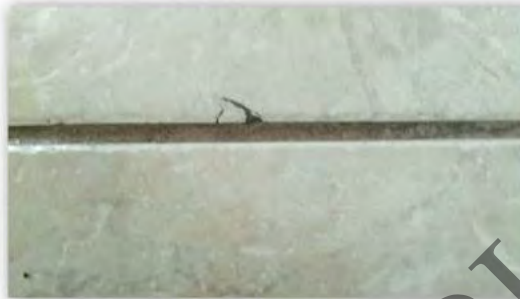
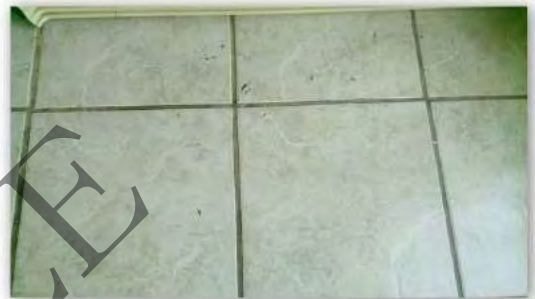
Floor cracks in one or more locations. [Kitchen] - "[§535.228 \(e\)\(2\)\(B\)](#)"

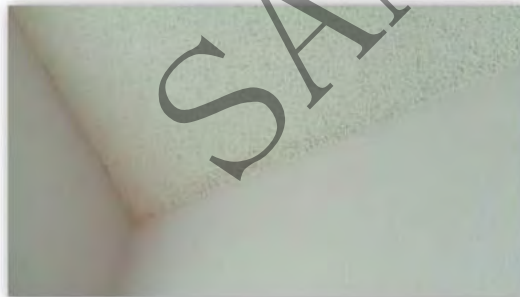
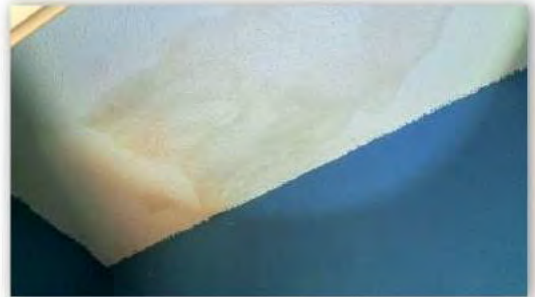
Ceiling has water staining at [Front right bedroom] See the section: "Roof Covering Materials" for additional details regarding the moisture penetration. - "[§535.228 \(e\)\(2\)\(B\)](#)"

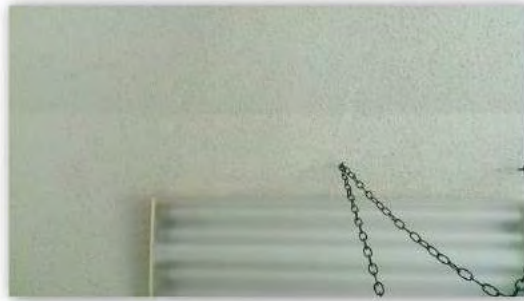
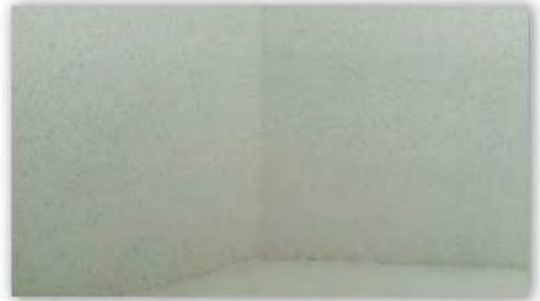
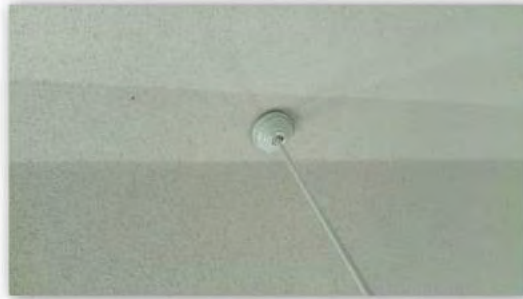
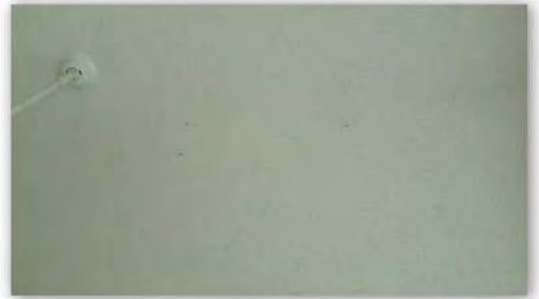
"Nail Pop" at: [Multiple locations] - Nail pops in drywall walls or ceilings are usually a minor cosmetic issue that is common in new construction. As wood studs shrink, nail heads 'pop' out from the drywall surface, causing a bump or the blemish on the wall or ceiling. This usually happens on new work, and only one time. Repair is straightforward, though some nails may require screws on either side of them to secure the area from expansion. Nail pop repairs are typically done just prior to repainting the surface. "[§535.228\(e\)\(3\)](#)"

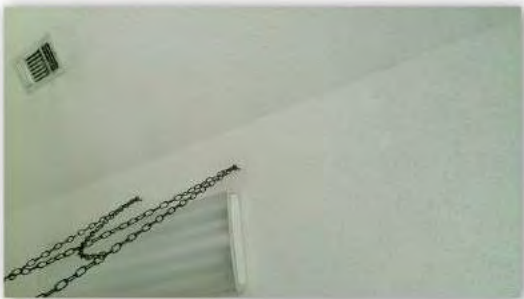
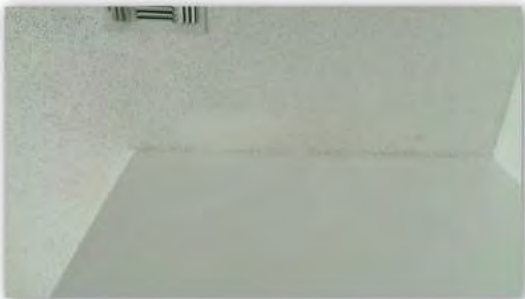
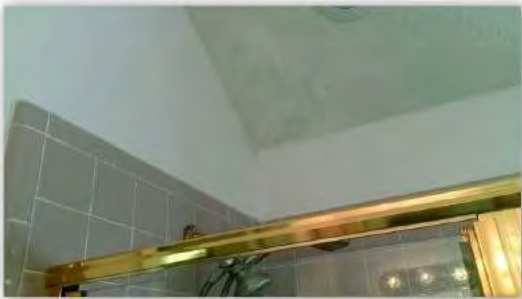
Signs of repairs observed in one or more locations. at: [Multiple locations] - "[§535.228 \(e\)\(3\)](#)"

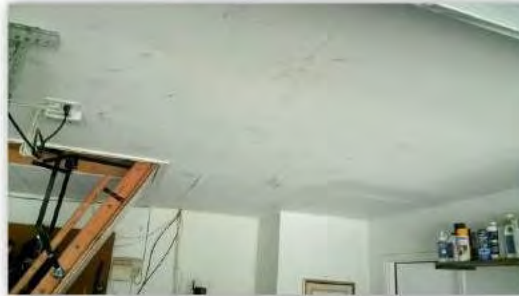
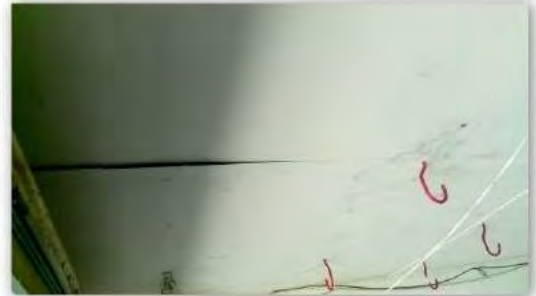
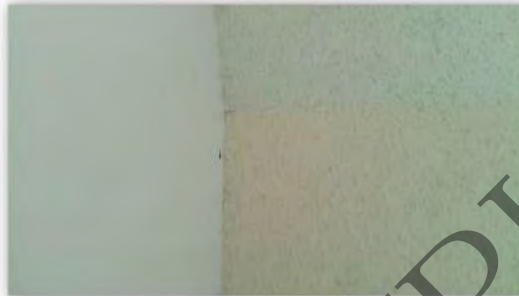
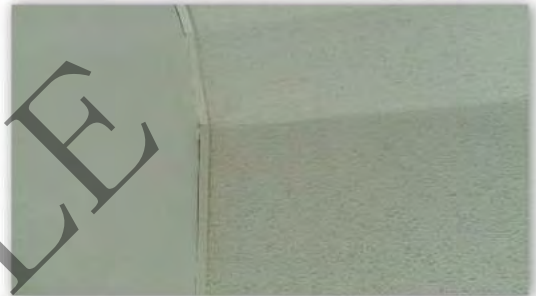
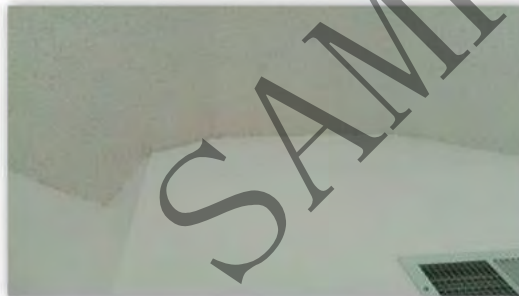
Separation at ceiling drywall seam at: [Multiple locations] - Seam cracks are typically associated with expansion or contraction and are common even in new construction. Patch as desired. "[§535.228 \(e\)\(3\)](#)"

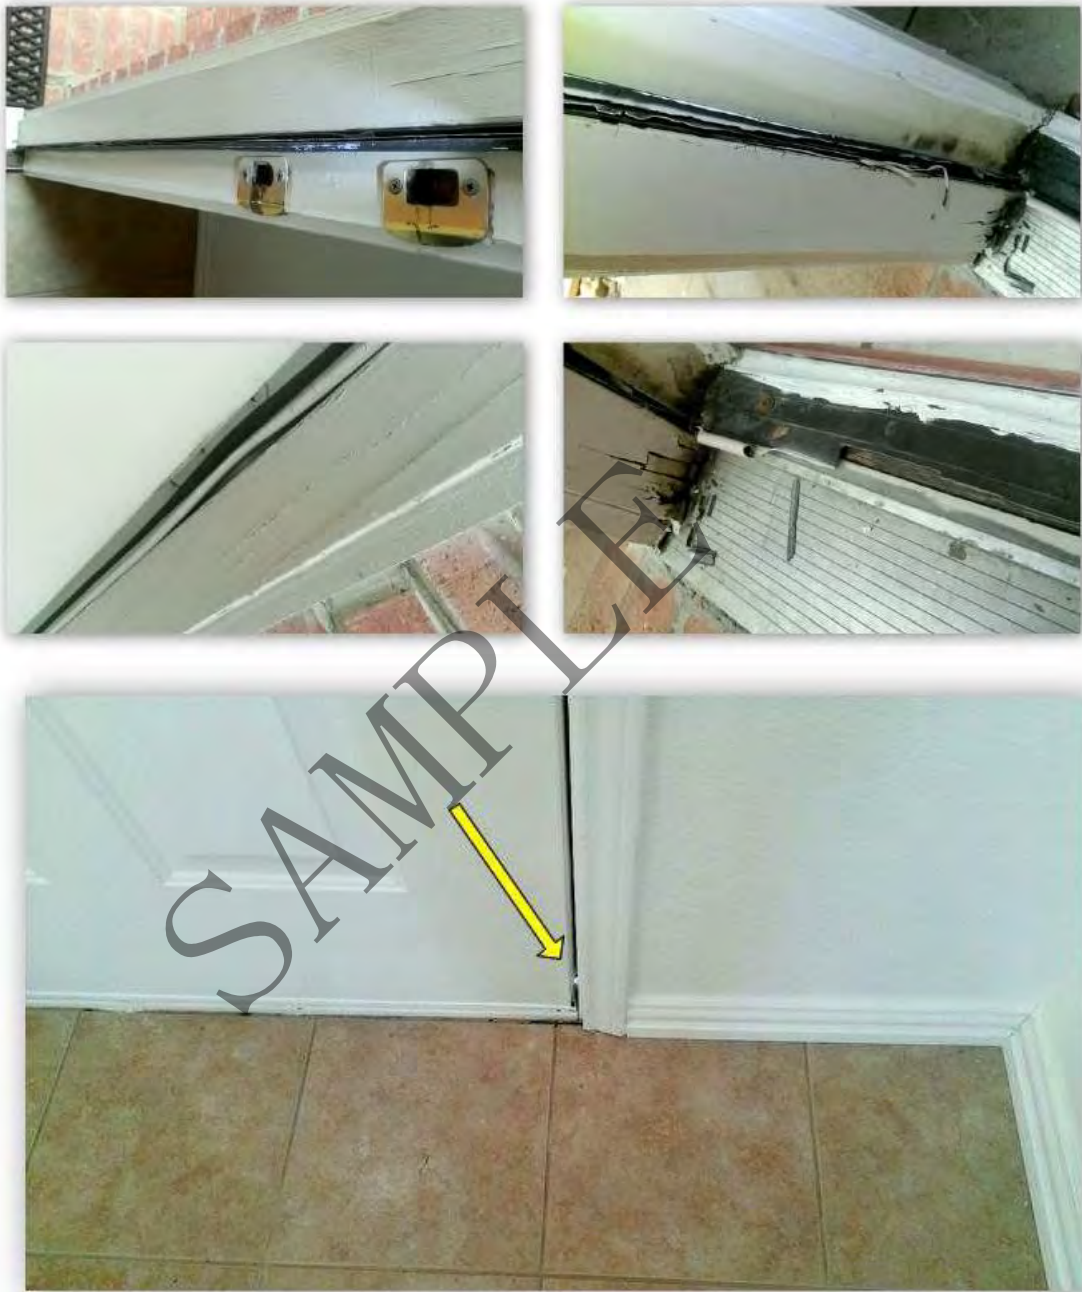
Weather stripping needed at: Front Entry Door, Rear Entry Door - "[§535.228 \(e\)\(2\)\(A\)](#)"

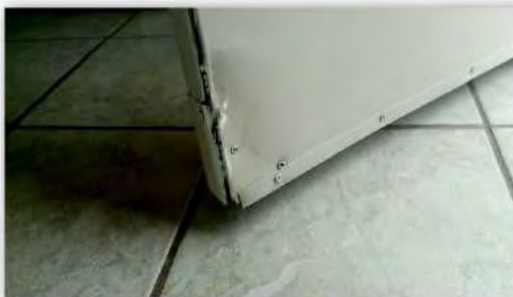
Doors are damaged at: Rear Entry Door - "[§535.228 \(e\)\(2\)\(A\)](#)"

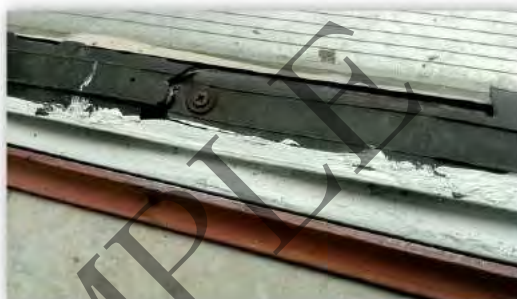
Damage to door framing at: Rear Entry Door - "[§535.228 \(e.f\)\(2\)](#)"

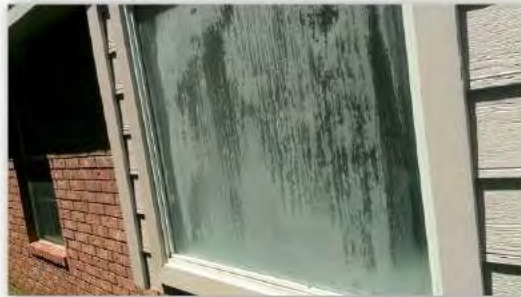
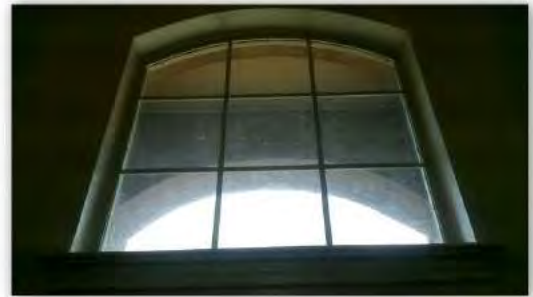
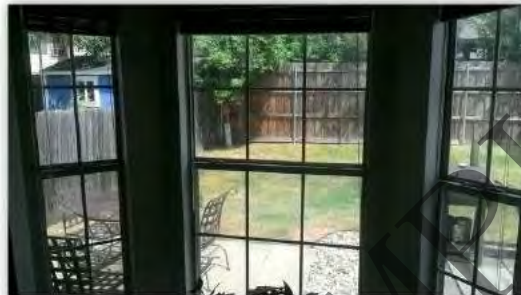
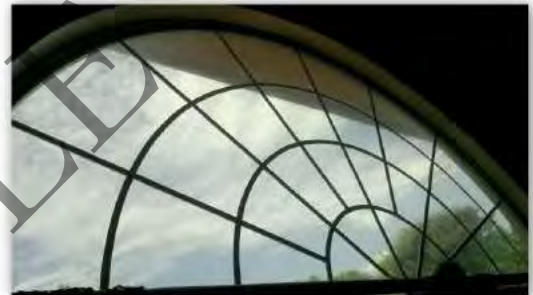
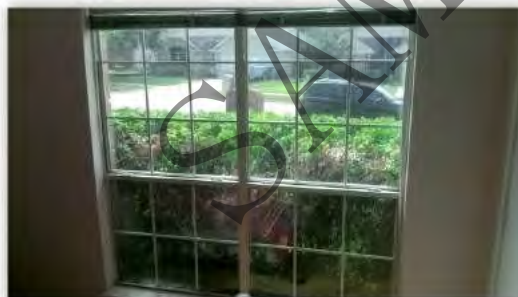
One or more dual paned thermal windows have seals that are breached at: [Multiple locations]; -Recommend obtaining an evaluative estimate for replacement or repair before closing. While some may last much longer, thermal windows typically have a 10-15 year life expectancy before some of the seals wear enough to cause observable conditions inside the panes. "[§535.228 \(g\)\(1\)\(B\)](#)"

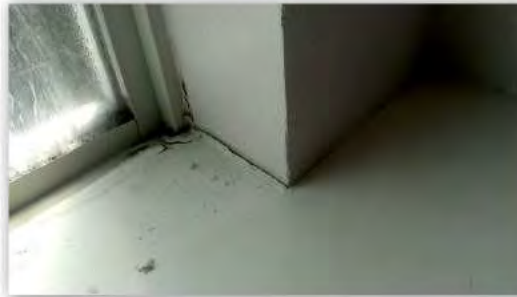
Water damage on window sill at: [Master bathroom]- "[§535.228 \(g\)\(1\)\(B\)](#)"

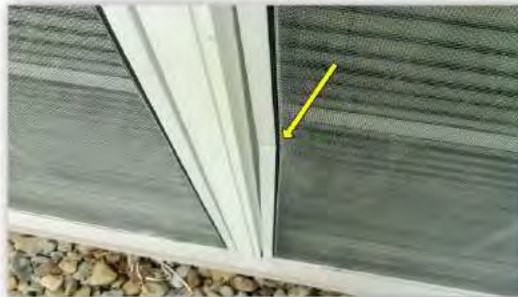
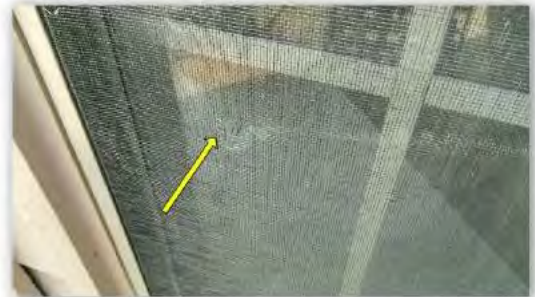
Screens are missing or damaged in one or more locations. - "[§535.228 \(g\)\(1\)](#)"

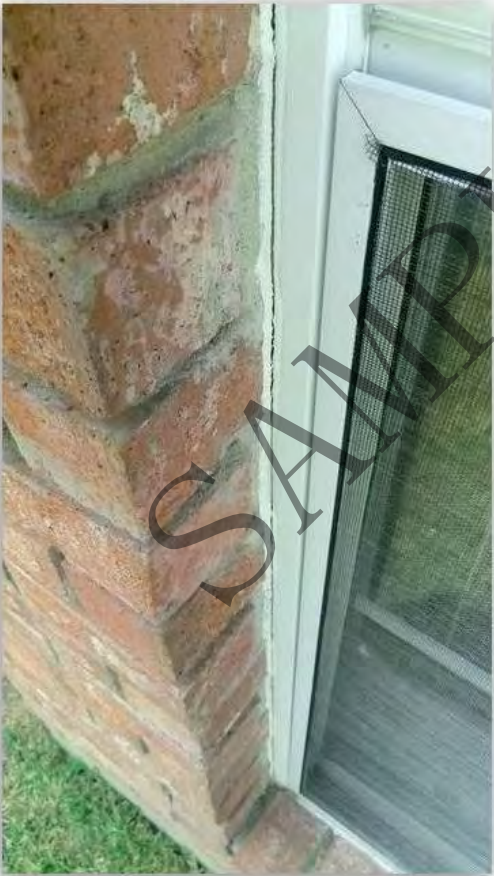
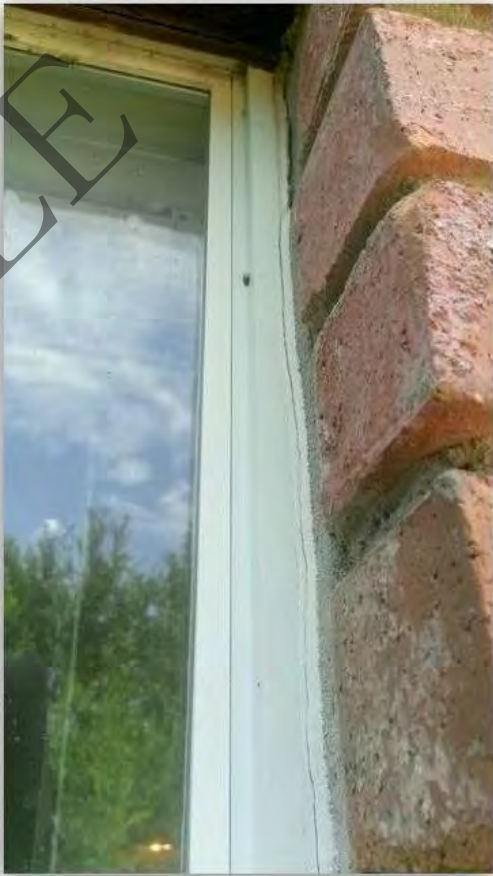
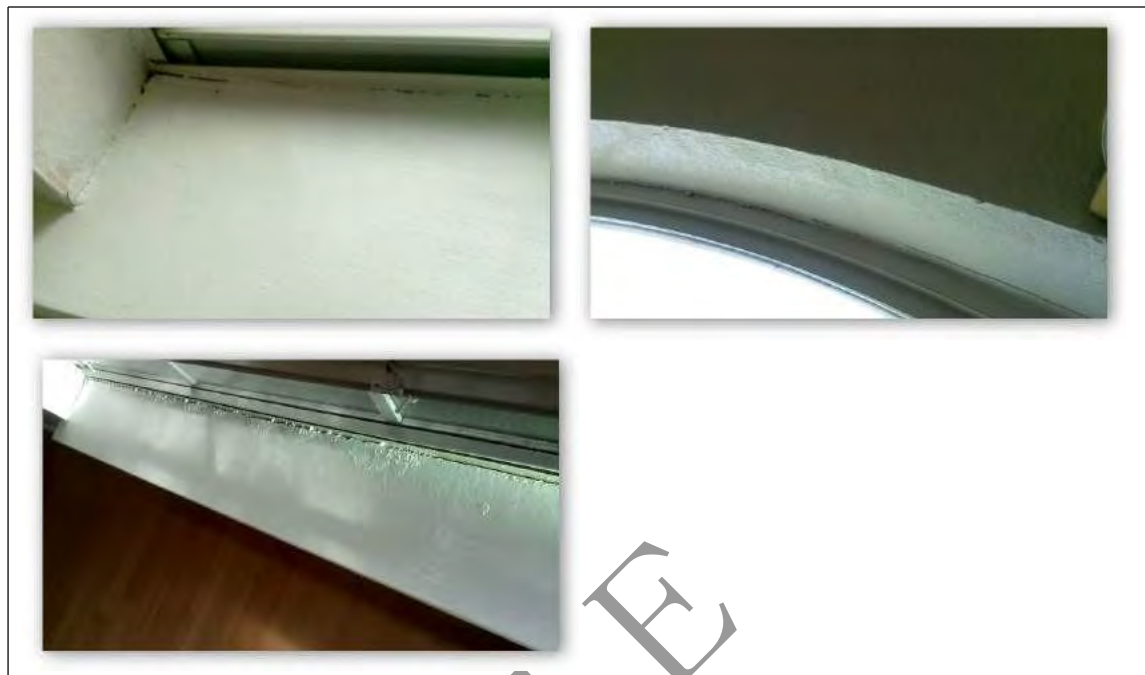
Window caulking is in need of repair or is missing in one or more locations. This is a regular maintenance item on both the interior and exterior of the home. - "[§535.228 \(g\)\(1\)\(B\)](#)" - "[§535.228 \(g\)\(1\)](#)"

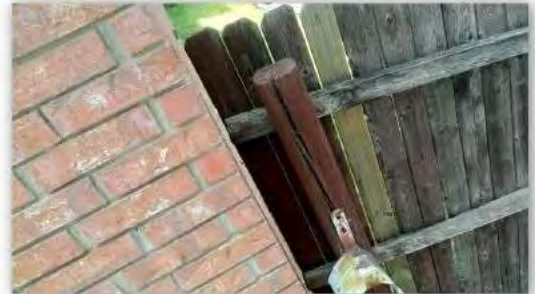
The fencing is in need of repair in one or more areas. Support posts are leaning and gate hardware is damaged or is no longer aligned properly. - "[§535.228](#)"
