III. HEATING, VENTILATION AND AIR CONDITIONING SYSTEMS

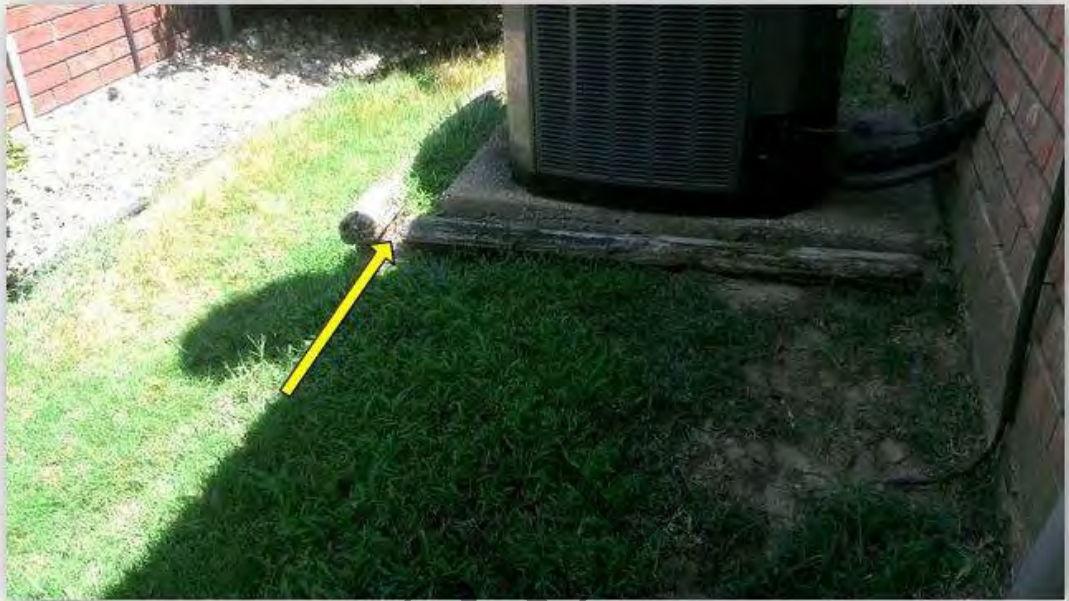
The retaining structure intended to support the grading around the condenser may need maintenance regularly to prevent loss of retention. - "[§535.230 \(b\)](#)"

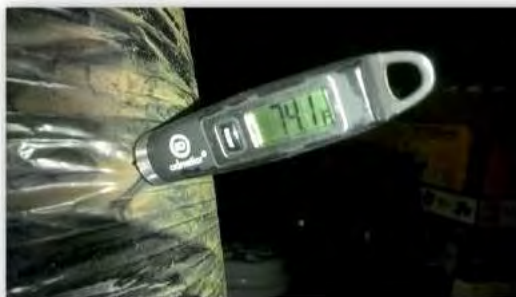
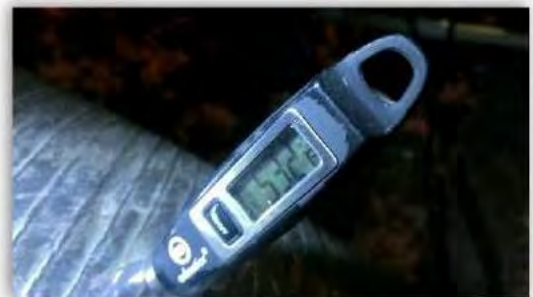
Temperature differential: - "[§535.230 \(b\)\(2\)\(B\)](#)"

(The difference in air temperature before and after entering the cooling system.

The desired range is 12-23 degrees.)

Unit #1 Temperature Differential: 21 degrees

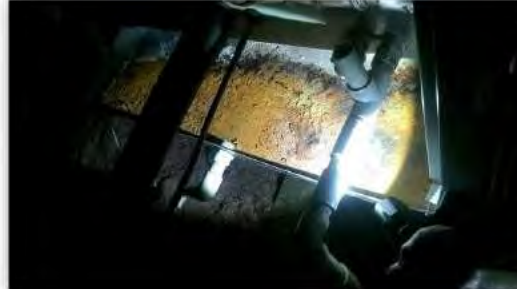
HVAC secondary drain pan condition: (This pan collects and exhausts excess moisture from the cooling component in the attic.)- "[§535.230 \(b\)](#)"

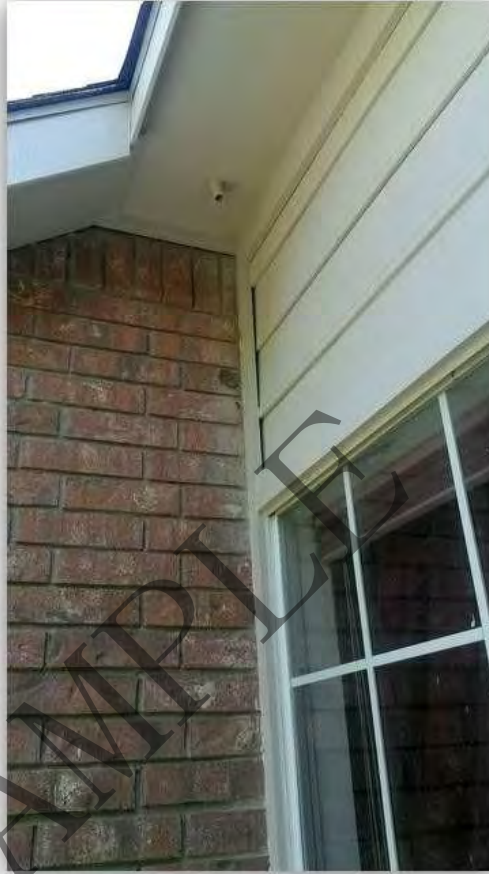
Location: HVAC condensation pan drip line location(This exhaust is required to be in a conspicuous location to notify of an HVAC unit that is in need of immediate maintenance.):

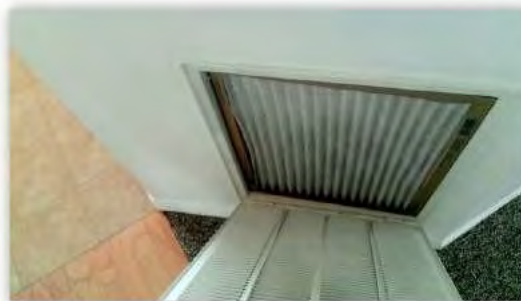
Location: HVAC Filter location(s):

Filter size: 20 X 25 X 1

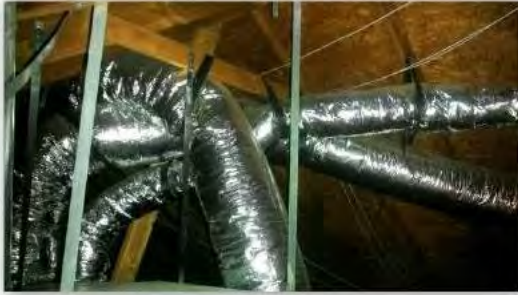
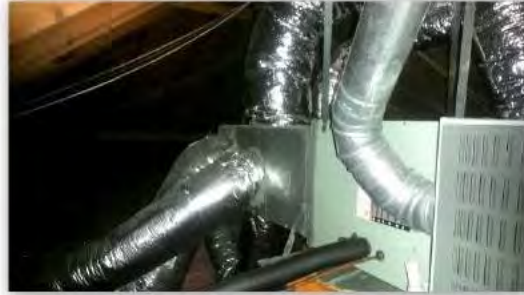
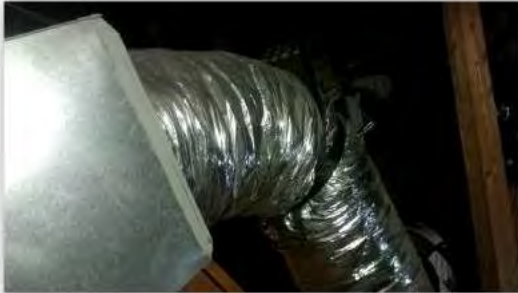
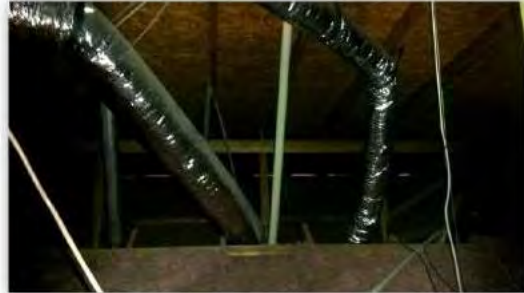
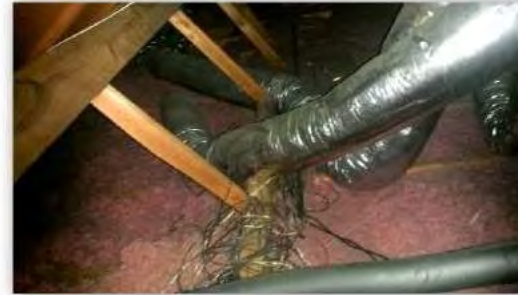
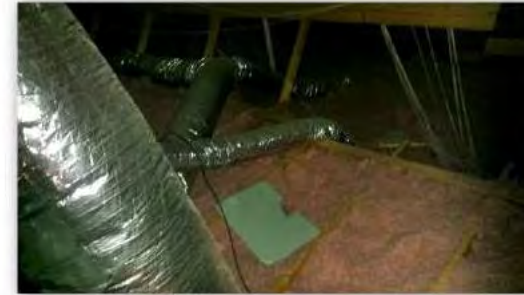
Ducting Photos- "\$535.230.(d)"
Additional Comments and Observations (This section may contain photographs that are not

Type of Ducting: Flex Ducting

Comments: Component(s) appear to be functioning as intended.
