#### IV. PLUMBING SYSTEMS

##### A. Plumbing Supply, Distribution Systems and Fixtures

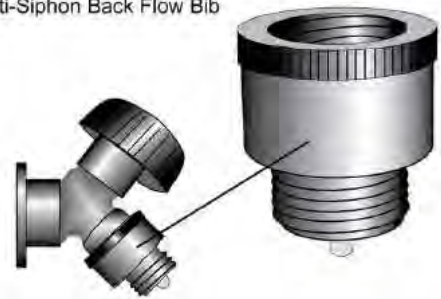
Anti-Siphon Back Flow Bib

The anti-siphon bib device prevents contaminated water from backing up into the potable water supply via a siphon effect. The anti-siphon device screws onto the threaded hose bib and is secured by using a set screw.
