I. STRUCTURAL SYSTEMS

A. Foundations

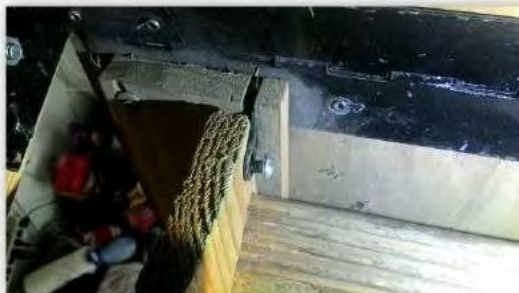
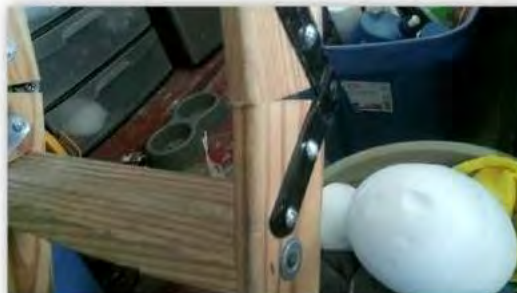
The attic access ladder/hatch is in need of adjustment/repair. - "[§535.228 \(d\)\(2\)\(D\)\(ii\)](#)"

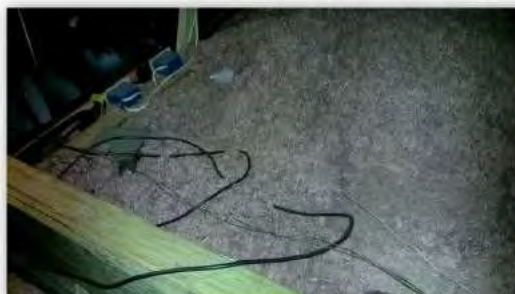
The insulation has been shuffled or has collapsed from it's intended installation and may not be providing adequate insulation. - "[§535.228 \(d\)\(2\)](#)"

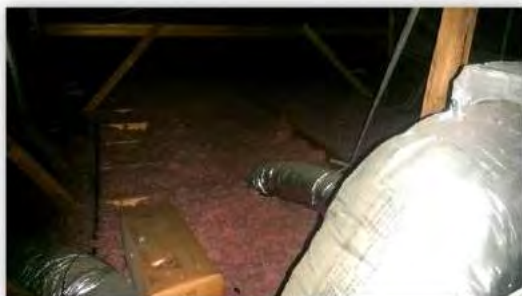
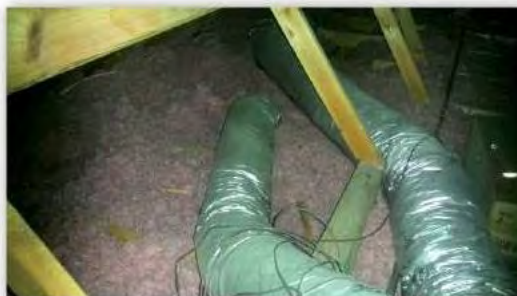
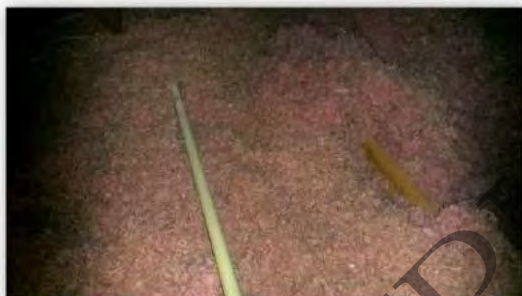
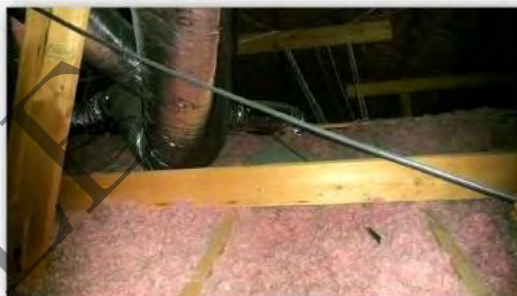
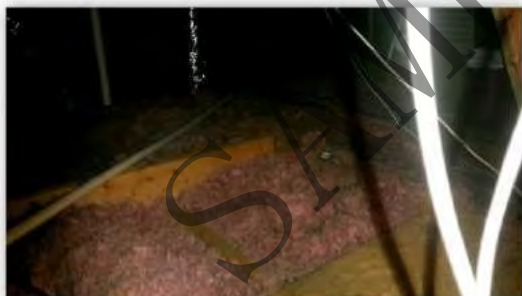
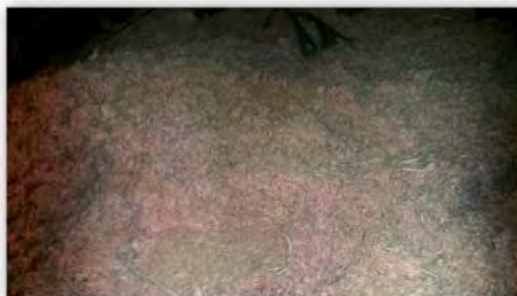
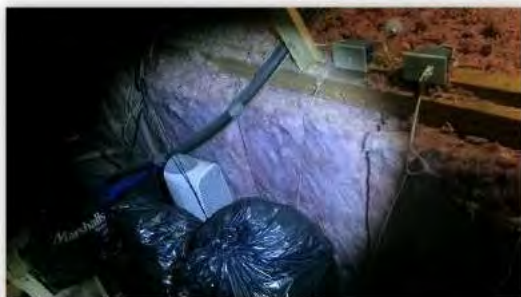
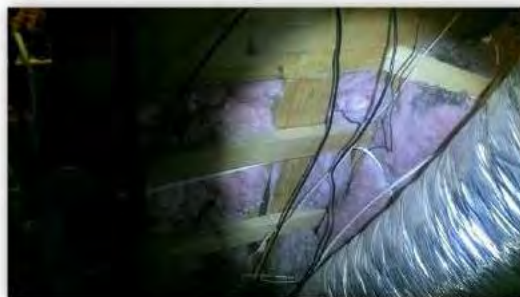
Insulation photos: - "[§535.228 \(d\)\(2\)](#)"

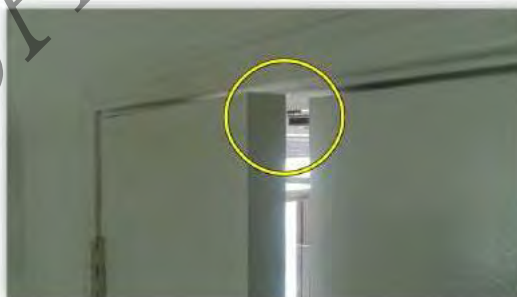
Doors do not latch properly at: Master Bedroom Bathroom Door - "[§535.228 \(e\)\(2\)\(A\)](#)"

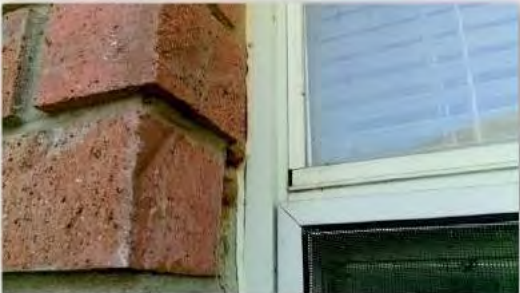
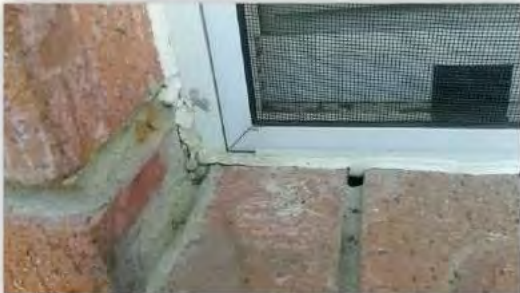
Window caulking is in need of repair or is missing in one or more locations. This is a regular maintenance item on both the interior and exterior of the home. - "[§535.228 \(g\)\(1\)\(B\)](#)" - "[§535.228 \(g\)\(1\)](#)"

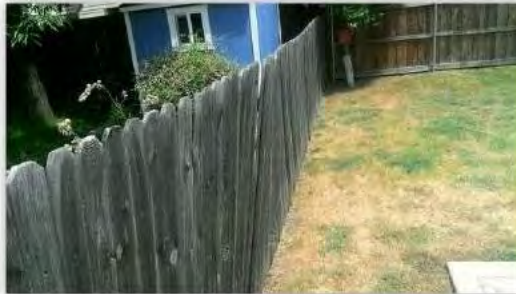
The fencing is in need of repair in one or more areas. Support posts are leaning and gate hardware is damaged or is no longer aligned properly. - "[§535.228](#)"
