V. APPLIANCES

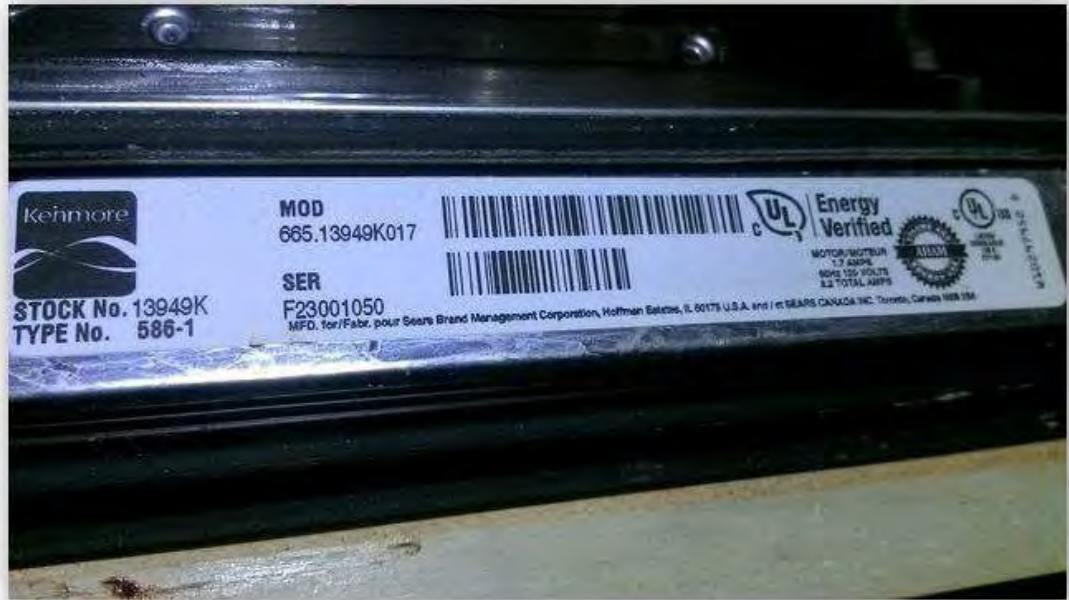
Label: Dishwasher - "[§535.232 \(a\)](#)"

*Comments:*Component(s) appear to be functioning as intended.

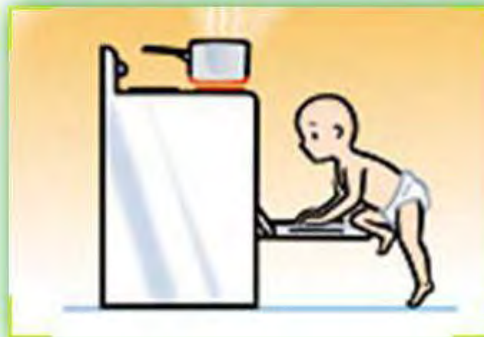
*Comments:*Component(s) functioning as intended, but minor deficiencies were observed.

There is no anti-tip device installed on the free-standing oven. - "[§535.232 \(d\)\(4\)](#)"

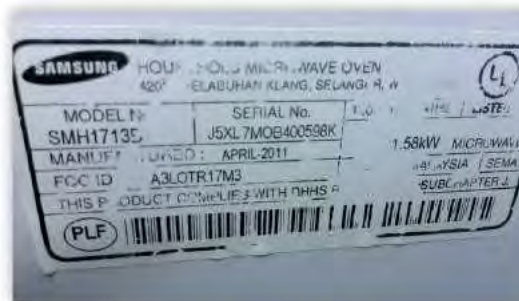
Label: Microwave

*Comments:*Component(s) appear to be functioning as intended.
